Great Division Wind Reservoir – Phase I

On Monday, August 9, 2021, a crew from Messrs. Czelusniak et Dugal, Inc., went to the First Church of Monson to disconnect and remove from the organ and the church the main wind reservoir for the Great division of the pipe organ, the same component then to proceed directly through the thorough shop releathering restoration. The following images document that entire process.

Pedal Division Wind Reservoirs – Phase II

Choir Division Wind Reservoir – Phase III

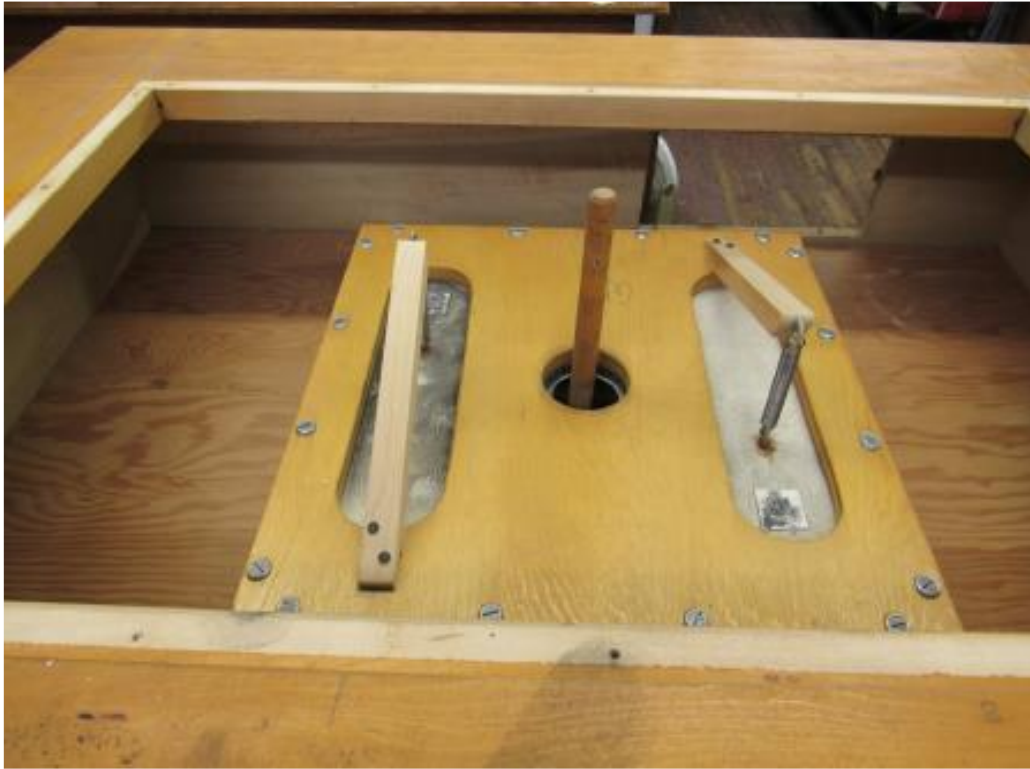
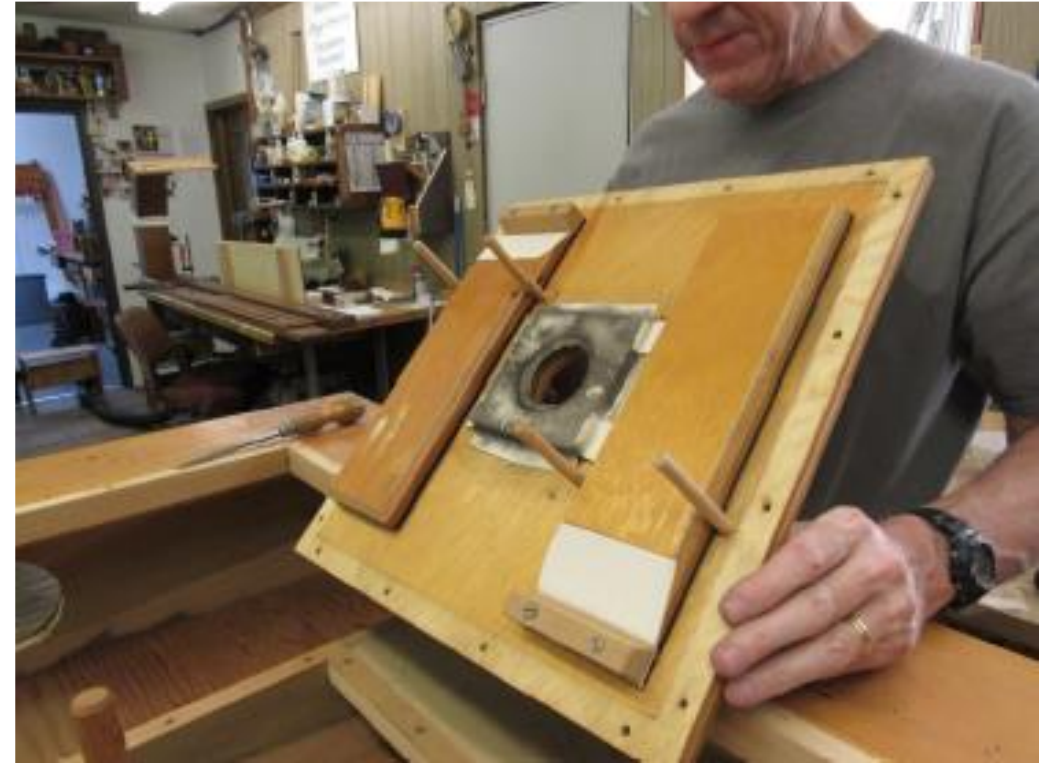
Back in the workshop, the full extent of age and deterioration were fully apparent.

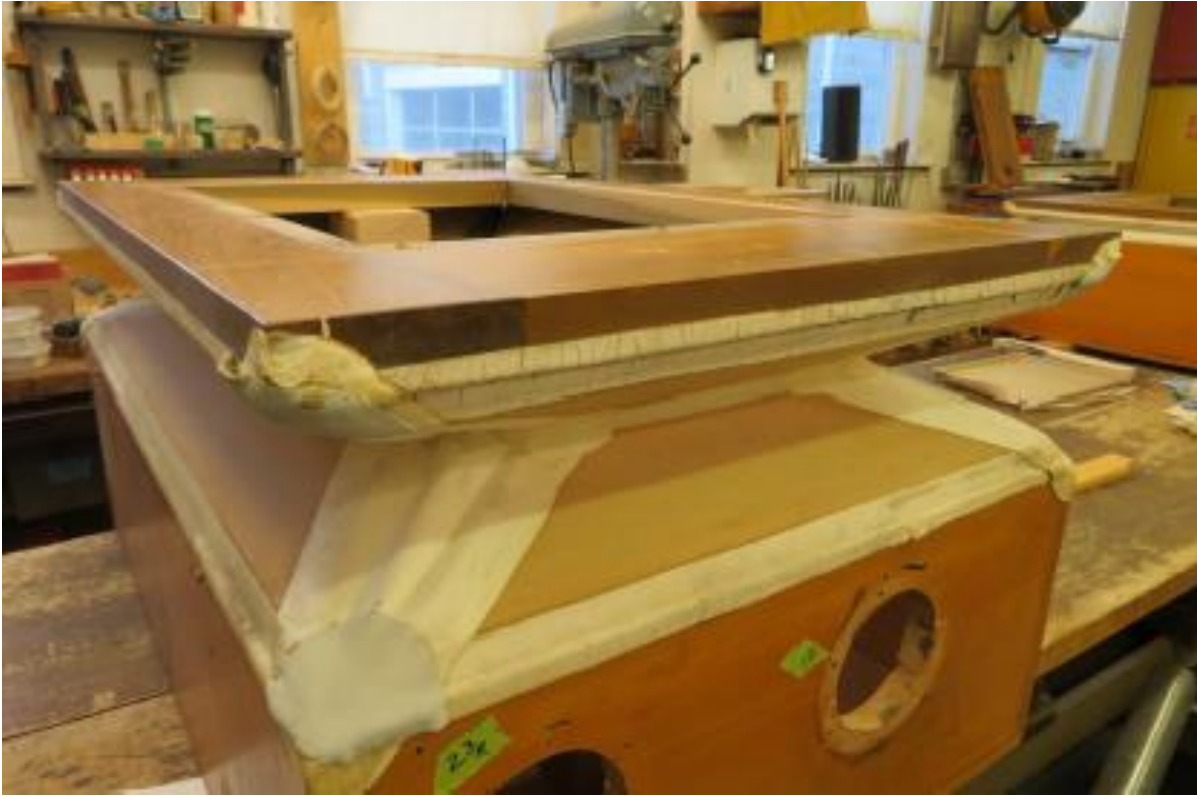
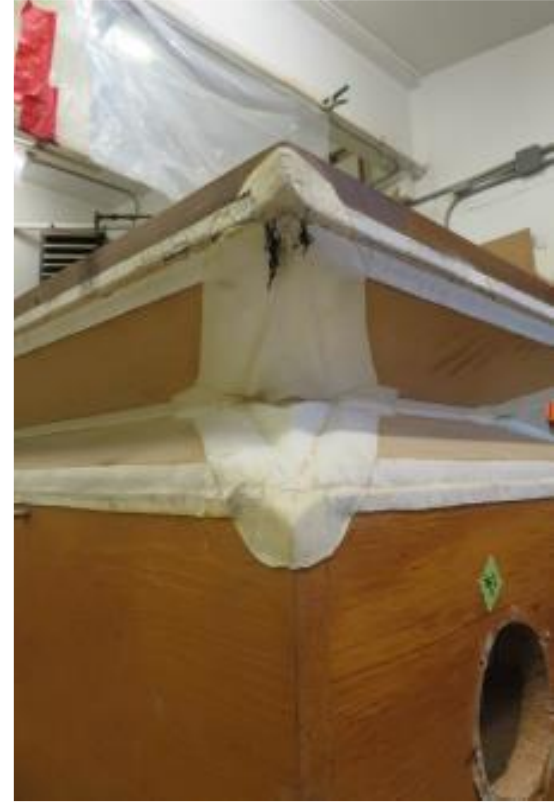
The image on the left illustrates the cracking rib leather and triage-based over-covers of leather on some corners. The image on the right illustrates at least one failing leather cover that was leaking to the atmosphere.

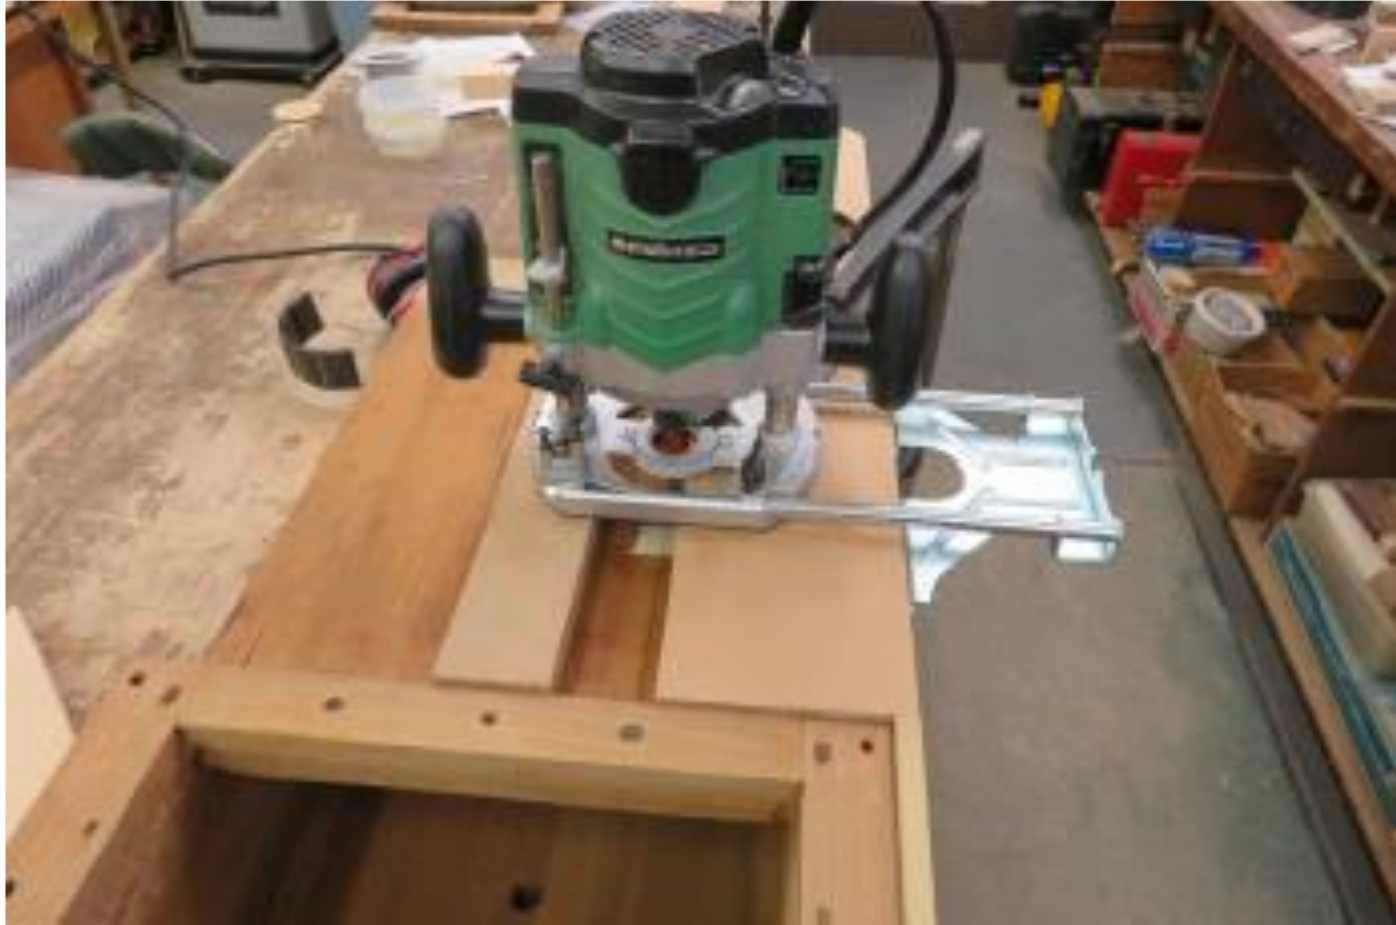
Cracks found within the wooden wind trunk were corrected permanently by routing out the split areas of the trunk and gluing in splines of aged and dry wood of similar species

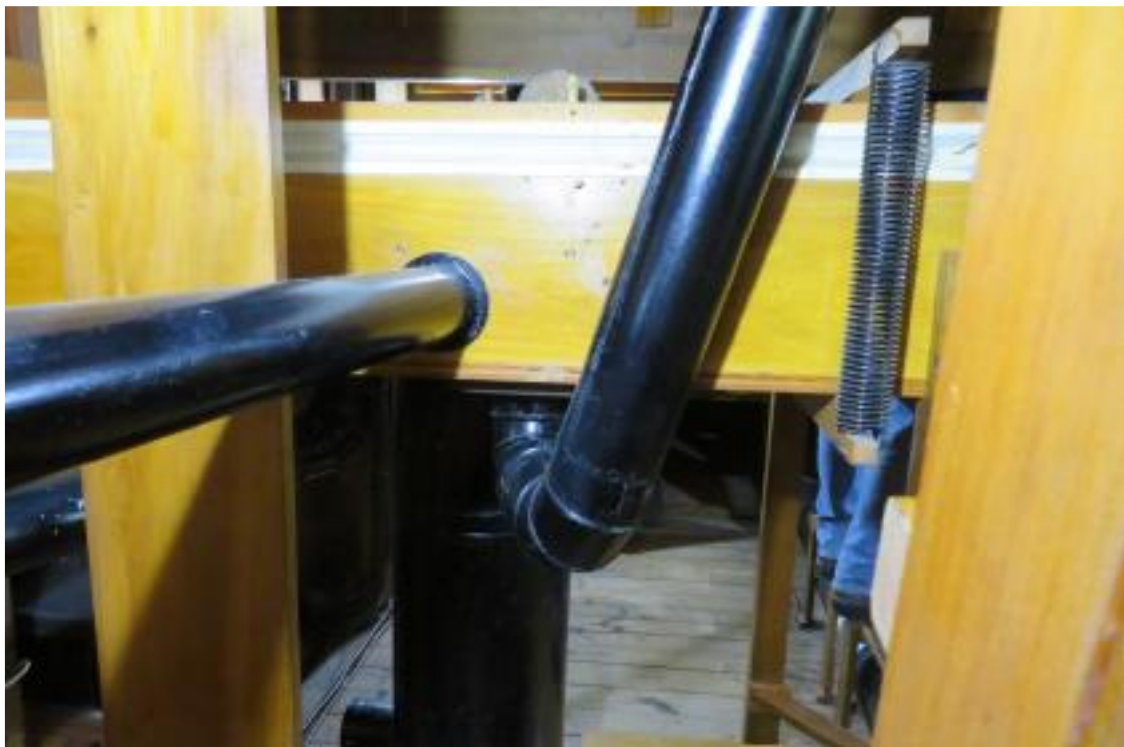
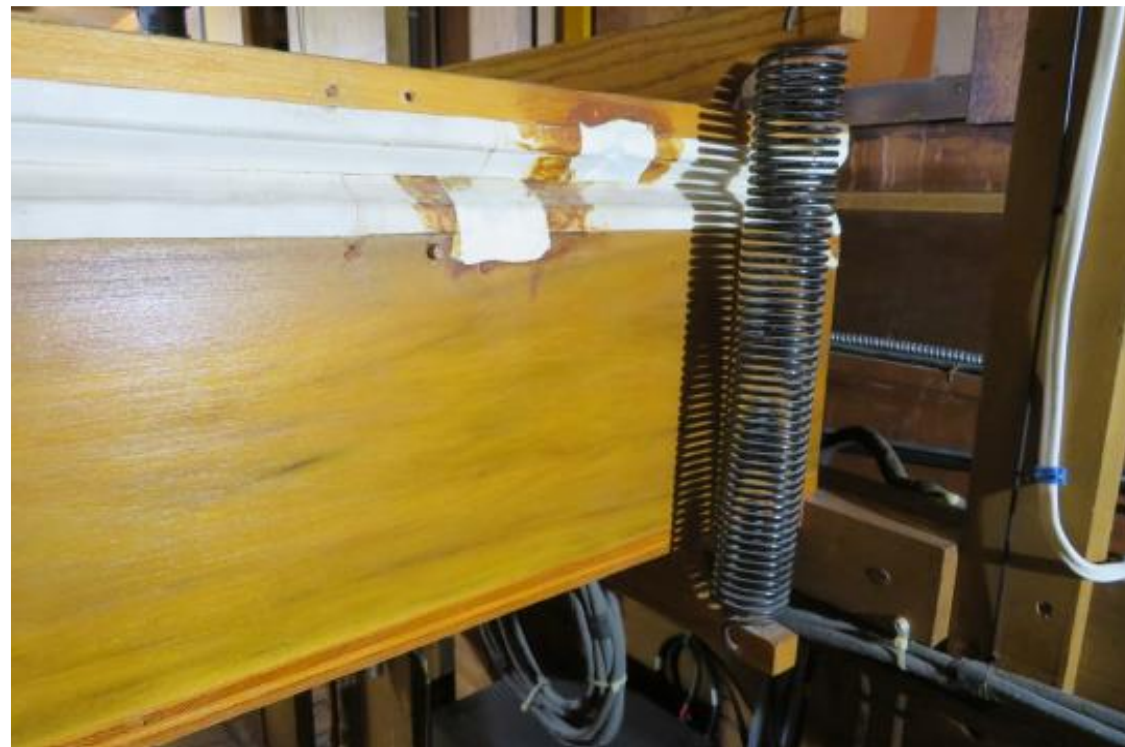
The Swell main wind reservoir, the first revealing considerable wind piping surrounding the unit and the leather deterioration found

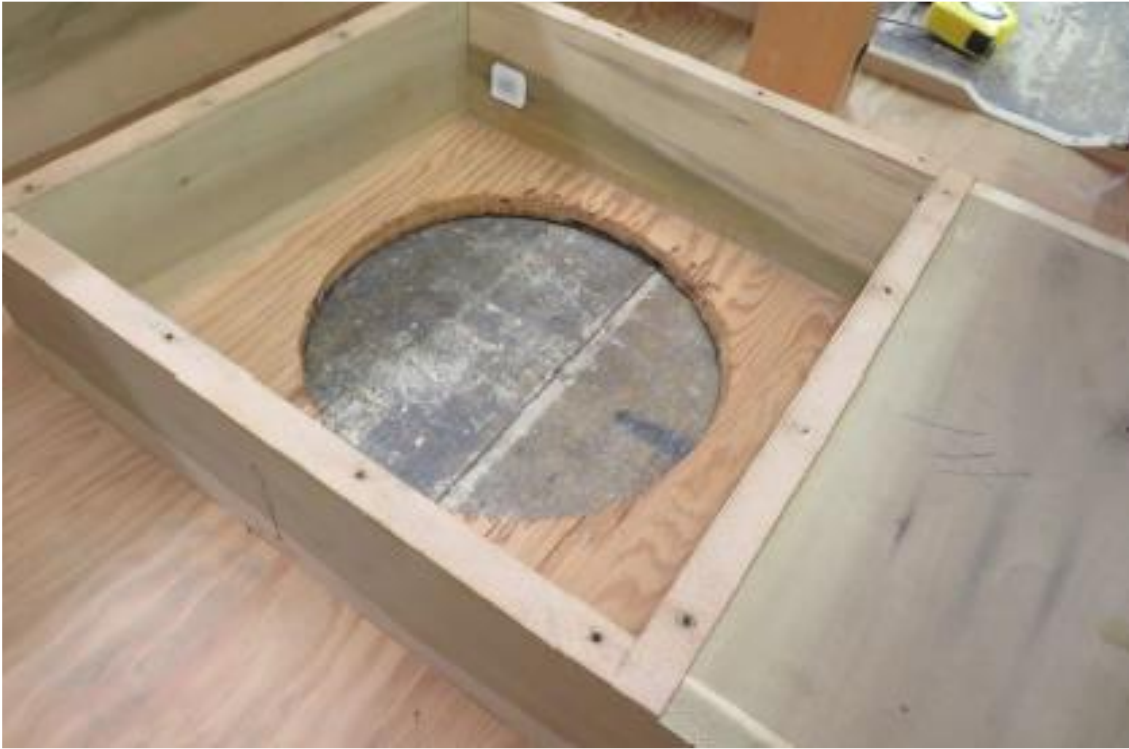
The interior conditions found with the static-wind feed hole in the Swell reservoir – repairs and improvements were made

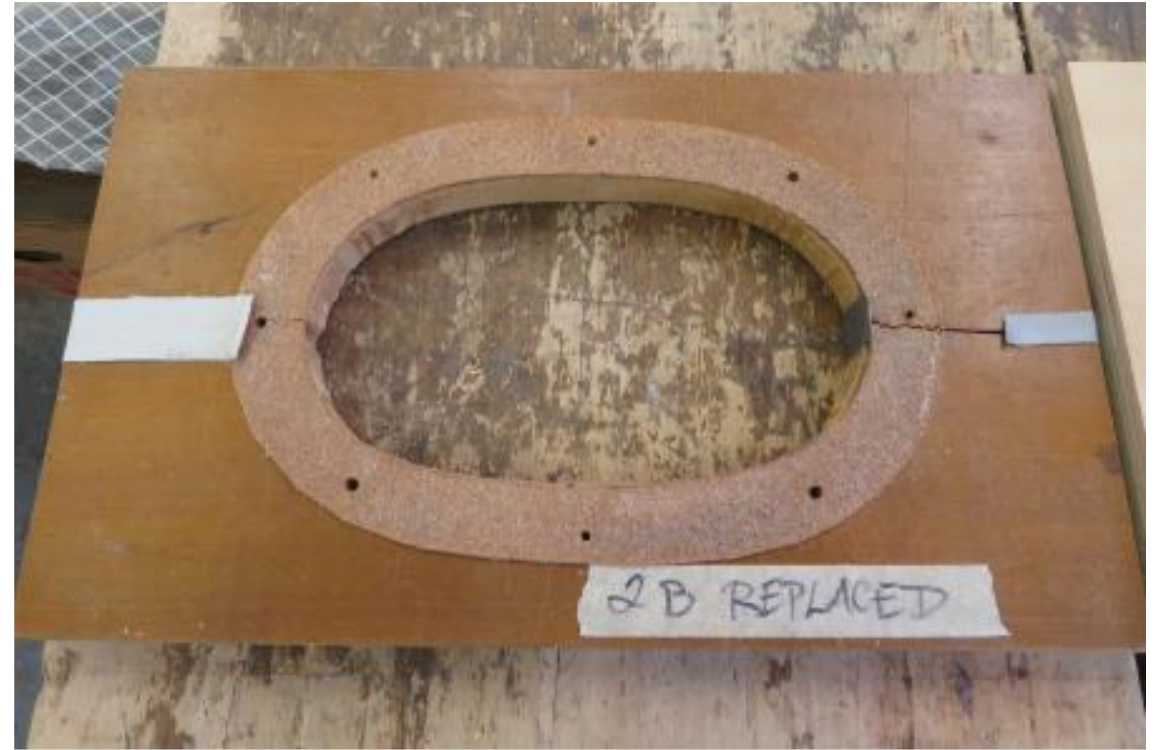
This flange plate on the wooden wind trunk to the Swell chest required replacement
