Great Division Wind Reservoir – Phase I

On Monday, August 9, 2021, a crew from Messrs. Czelusniak et Dugal, Inc., went to the First Church of Monson to disconnect and remove from the organ and the church the main wind reservoir for the Great division of the pipe organ, the same component then to proceed directly through the thorough shop releathering restoration. The following images document that entire process.

Pedal Division Wind Reservoirs – Phase II

Choir Division Wind Reservoir – Phase III

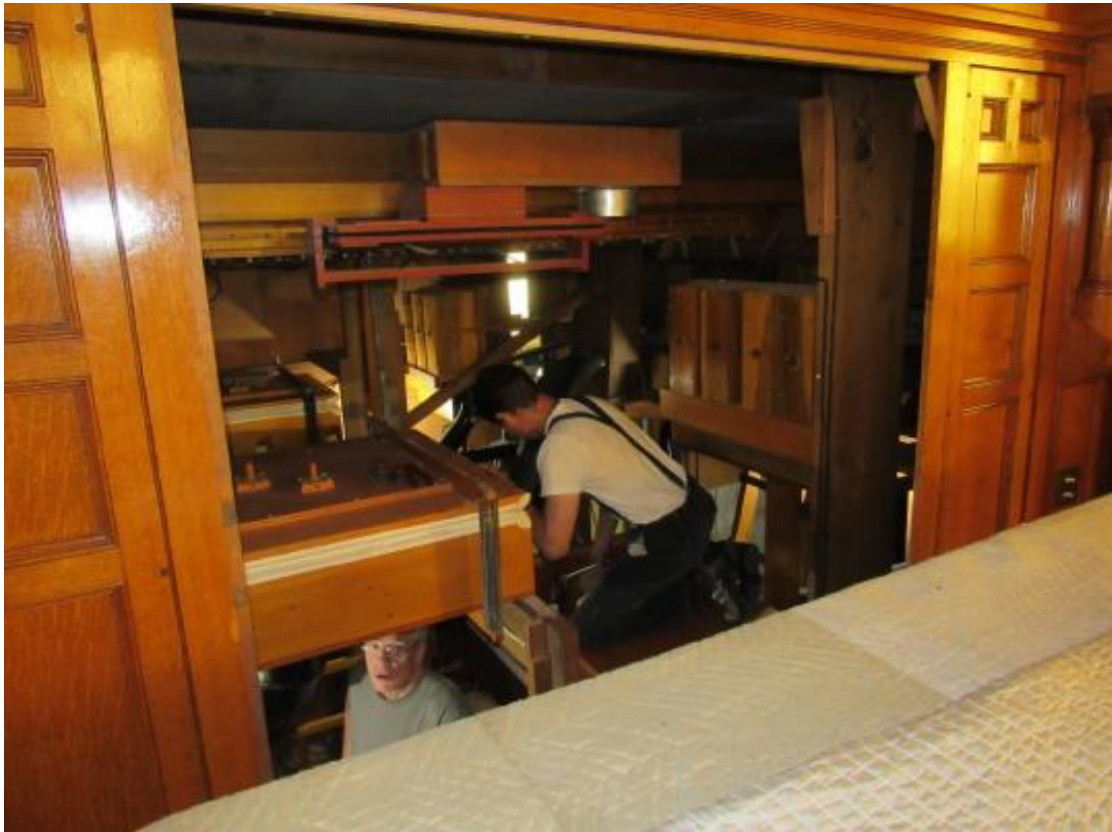
First, the removal of the reservoir

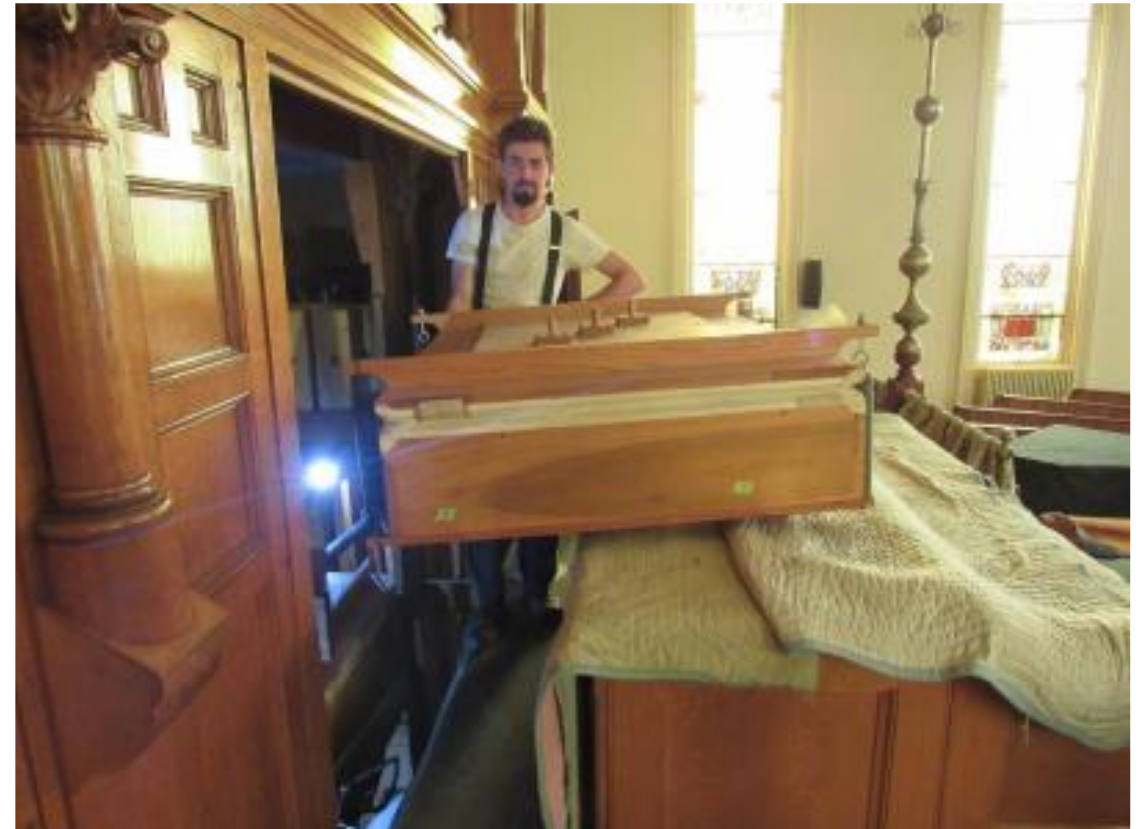
Out of the chamber, temporarily on top of the console, and then on its way out of the building

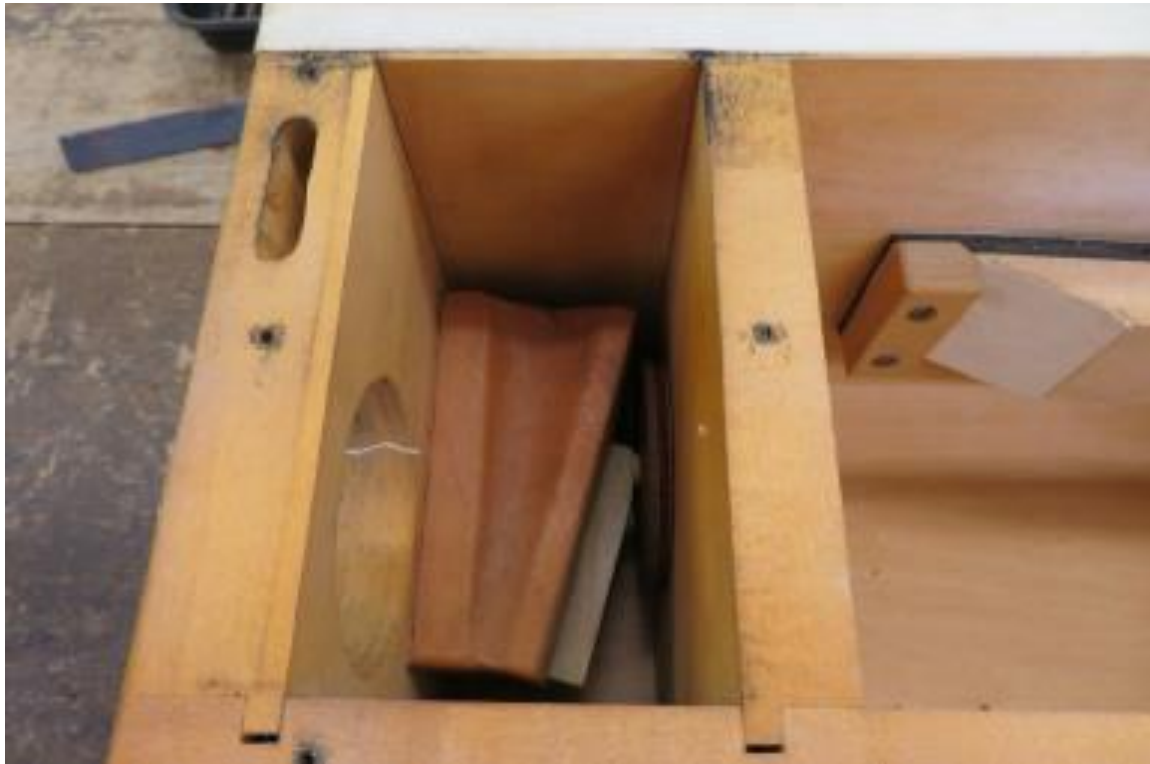
The large stop-action valve
inside the Tremolo

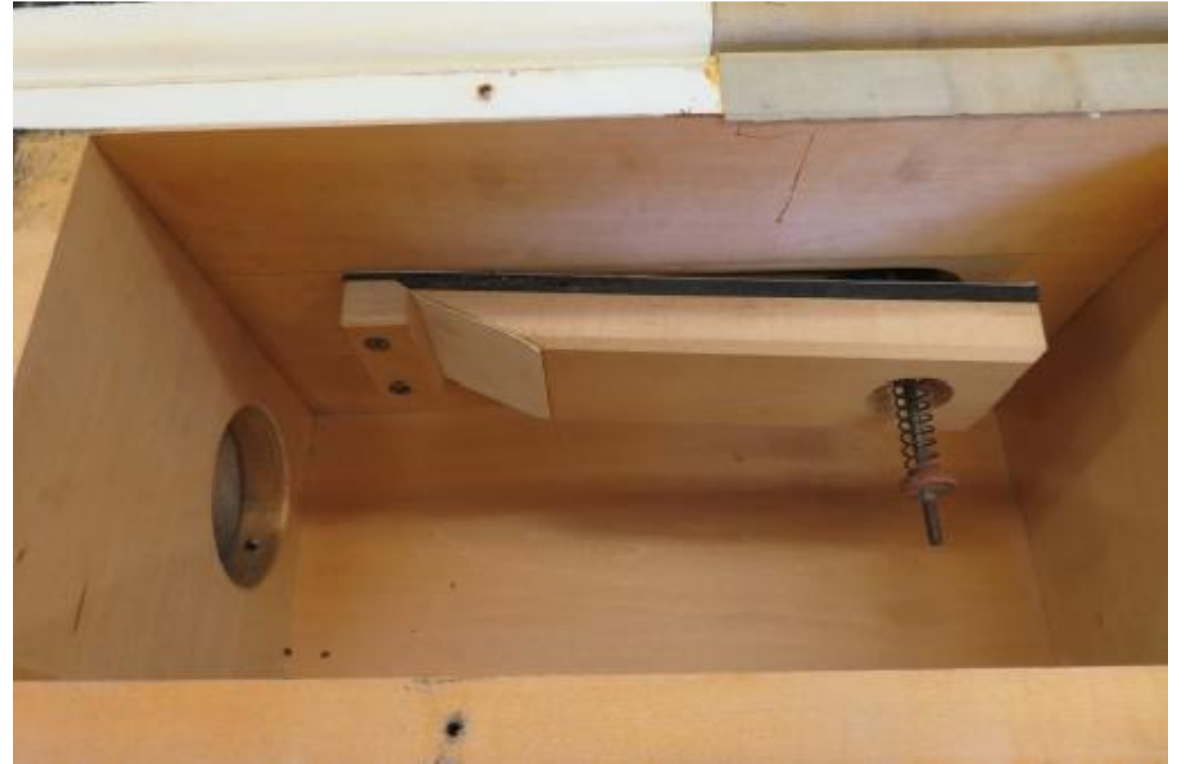
This is the internal pallet valve
in one Tremolo machine

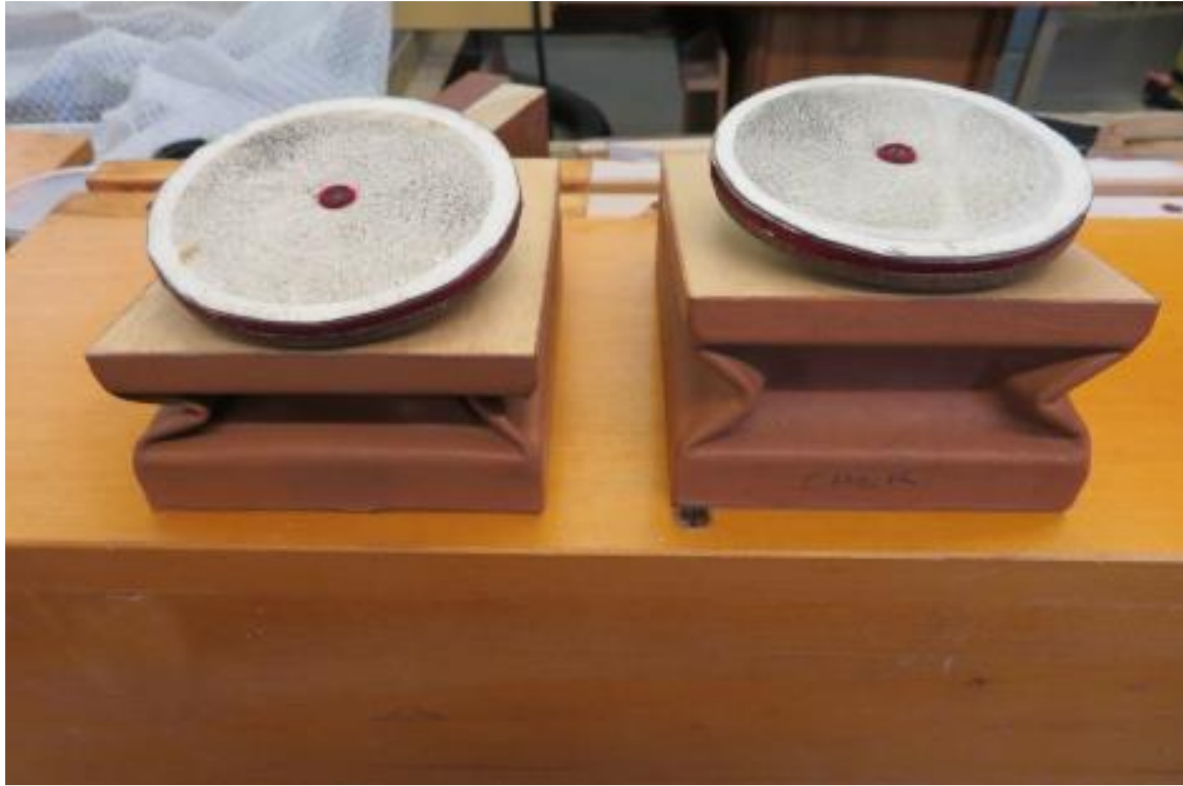
The two large disc valves that work as the stop actions for each of the two Tremolo
