Great Division Wind Reservoir – Phase I

On Monday, August 9, 2021, a crew from Messrs. Czelusniak et Dugal, Inc., went to the First Church of Monson to disconnect and remove from the organ and the church the main wind reservoir for the Great division of the pipe organ, the same component then to proceed directly through the thorough shop releathering restoration. The following images document that entire process.

Pedal Division Wind Reservoirs – Phase II

Choir Division Wind Reservoir – Phase III

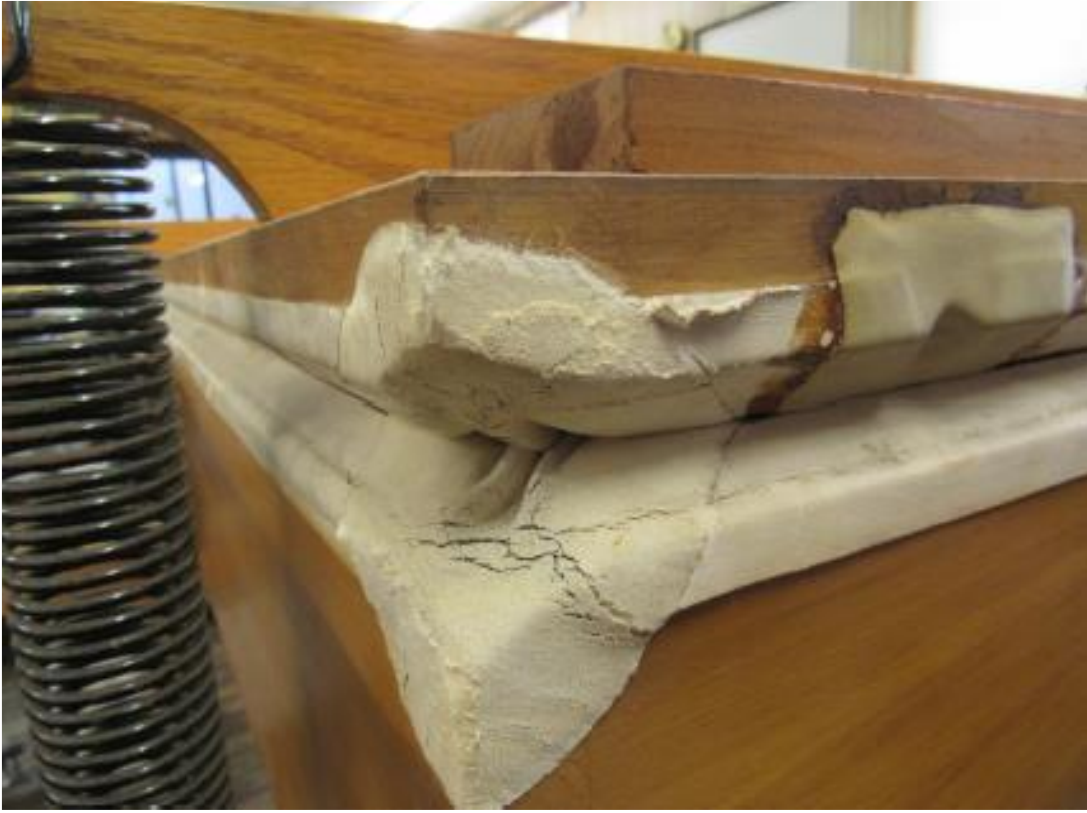
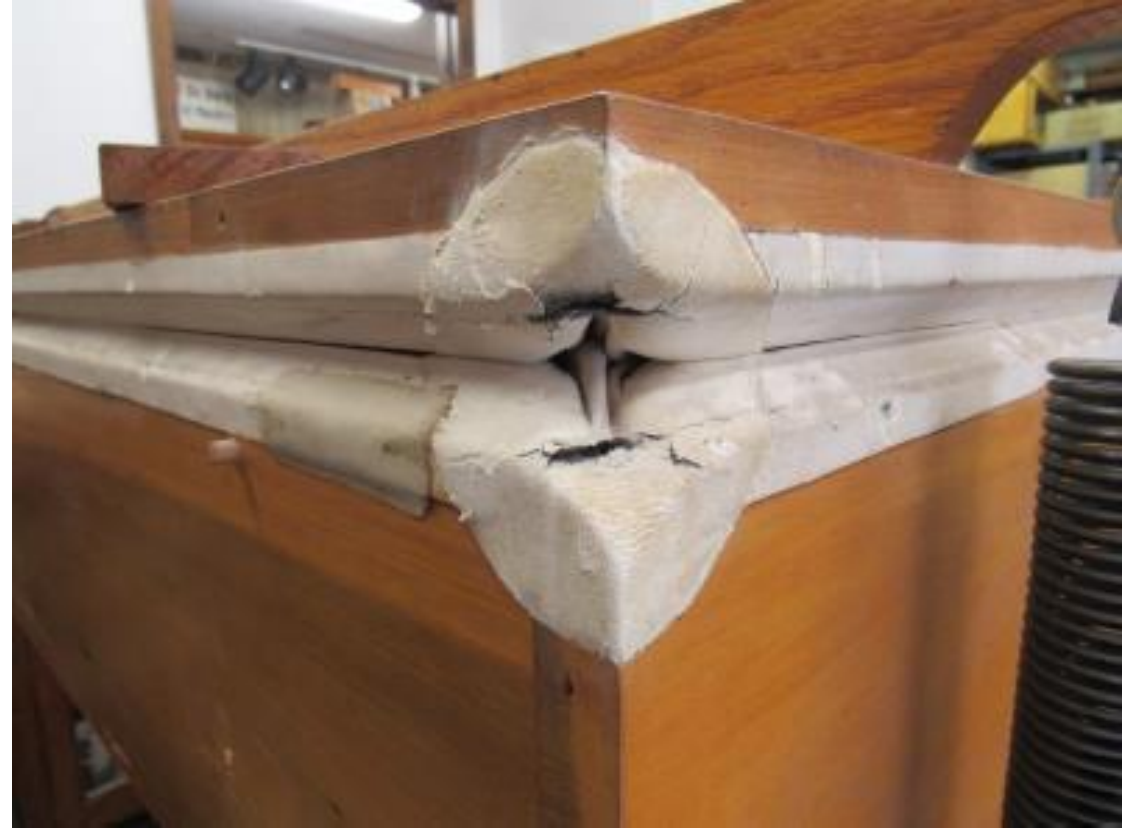
Back in the workshop, the full extent of age and deterioration were fully apparent.

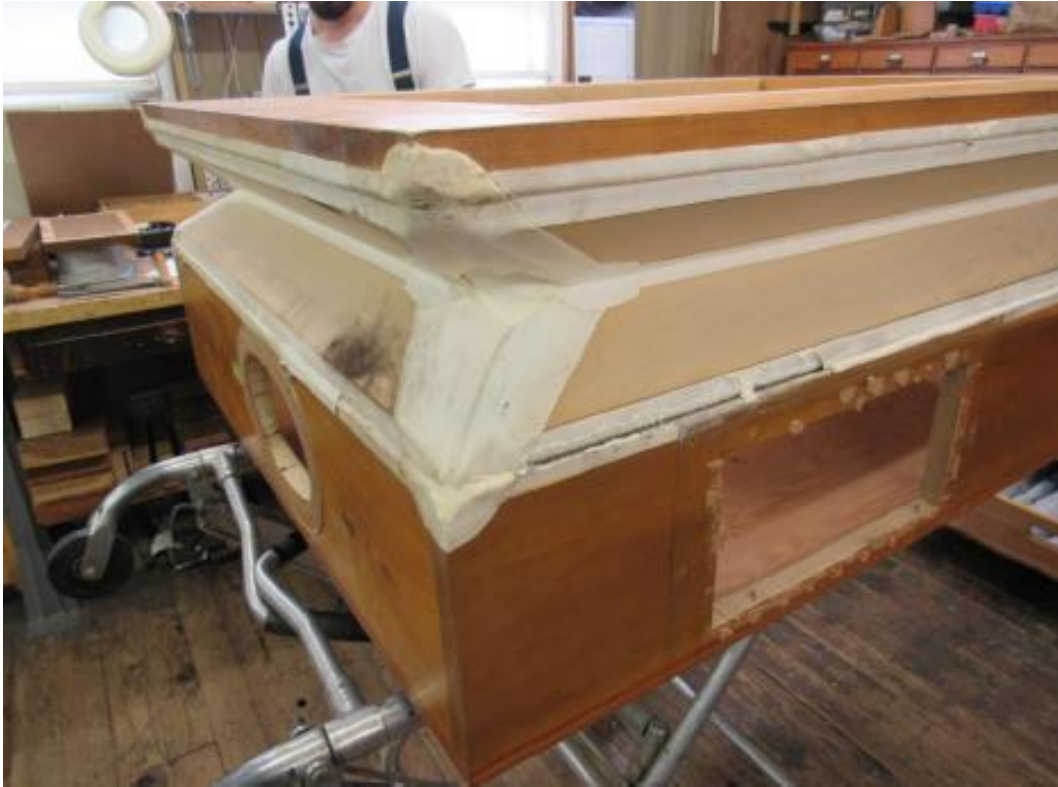
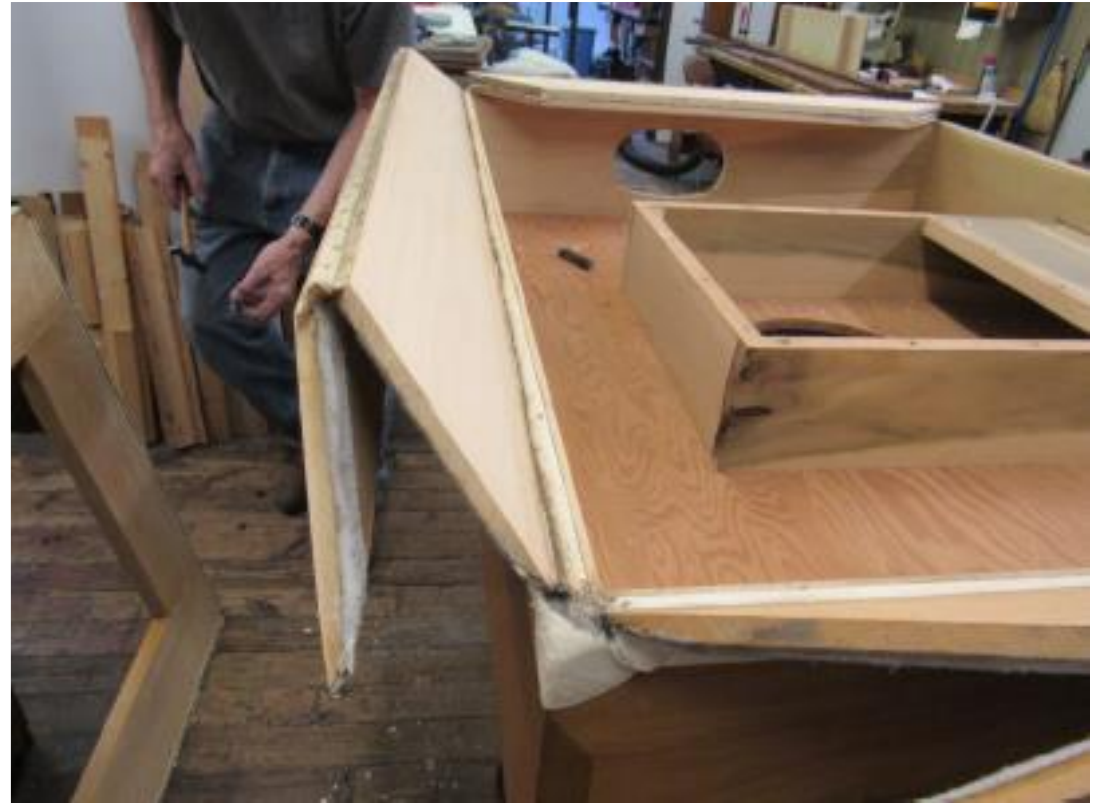
The dimensions of the rest of the reservoir (expansion especially) were documented, and the bellows ribs and gussets started to come apart for stripping and cleaning.

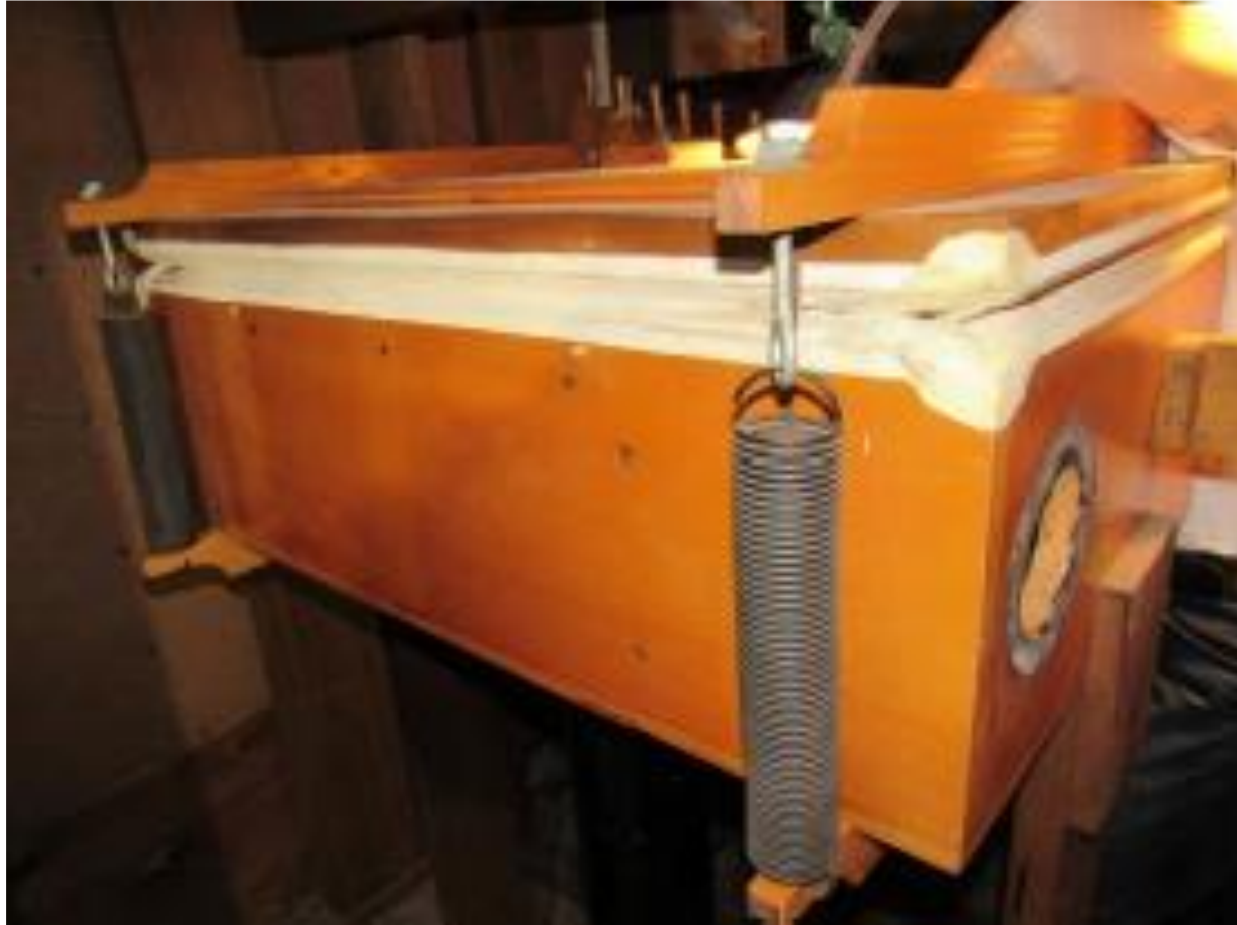
This image is the reservoir from within the more accessible right side of the organ case

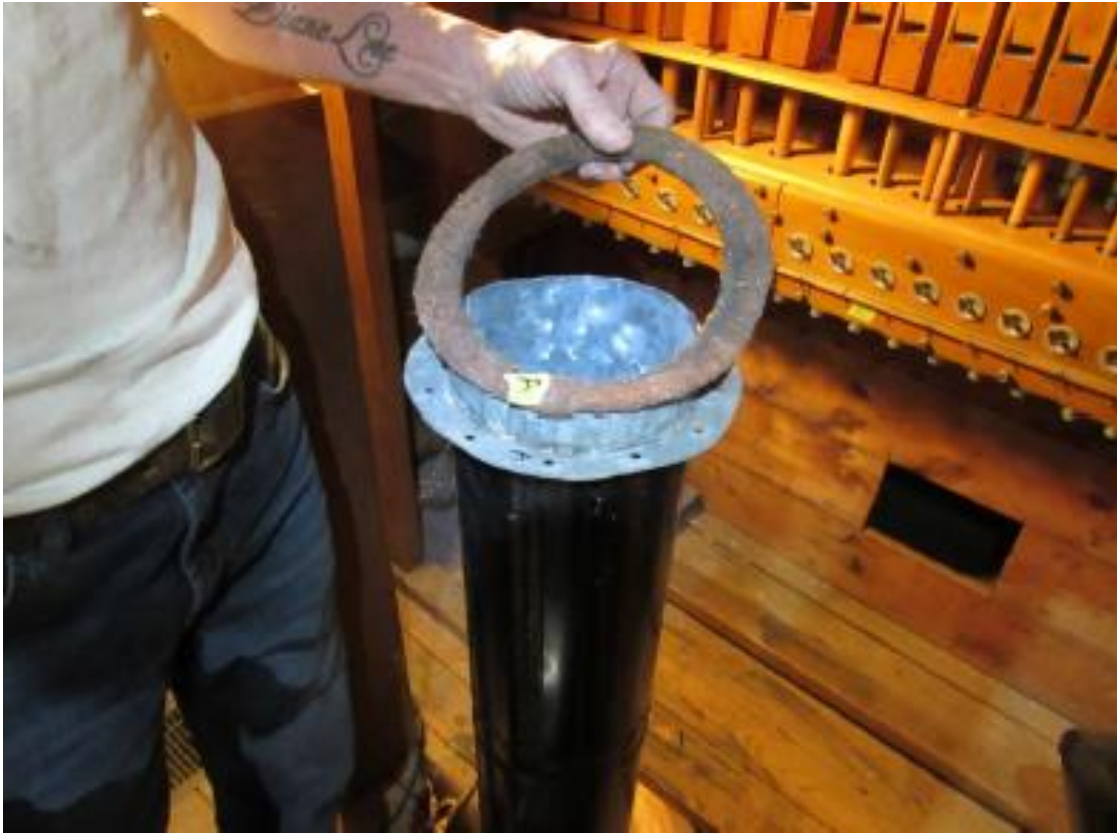
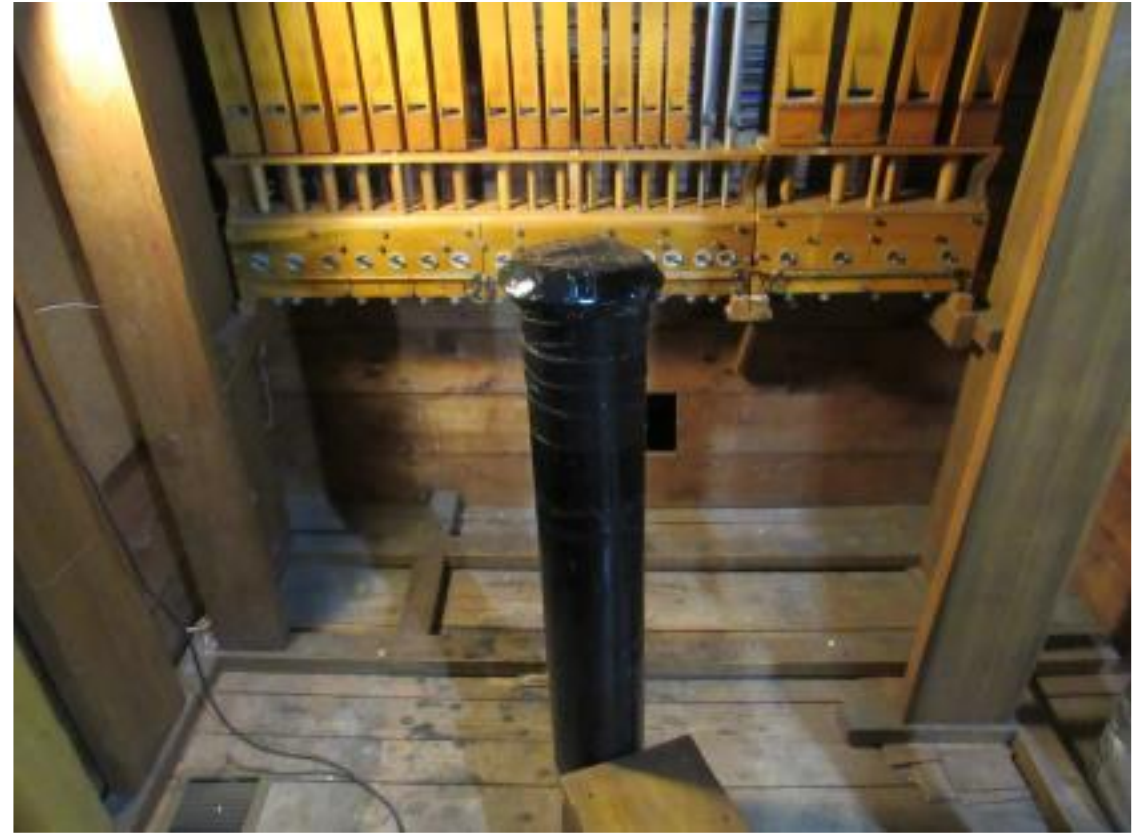
Pedal-stop treble pipes are visible to the rear, as the wind-feed pipe to that wind reservoir and the same pipe sealed off temporarily.

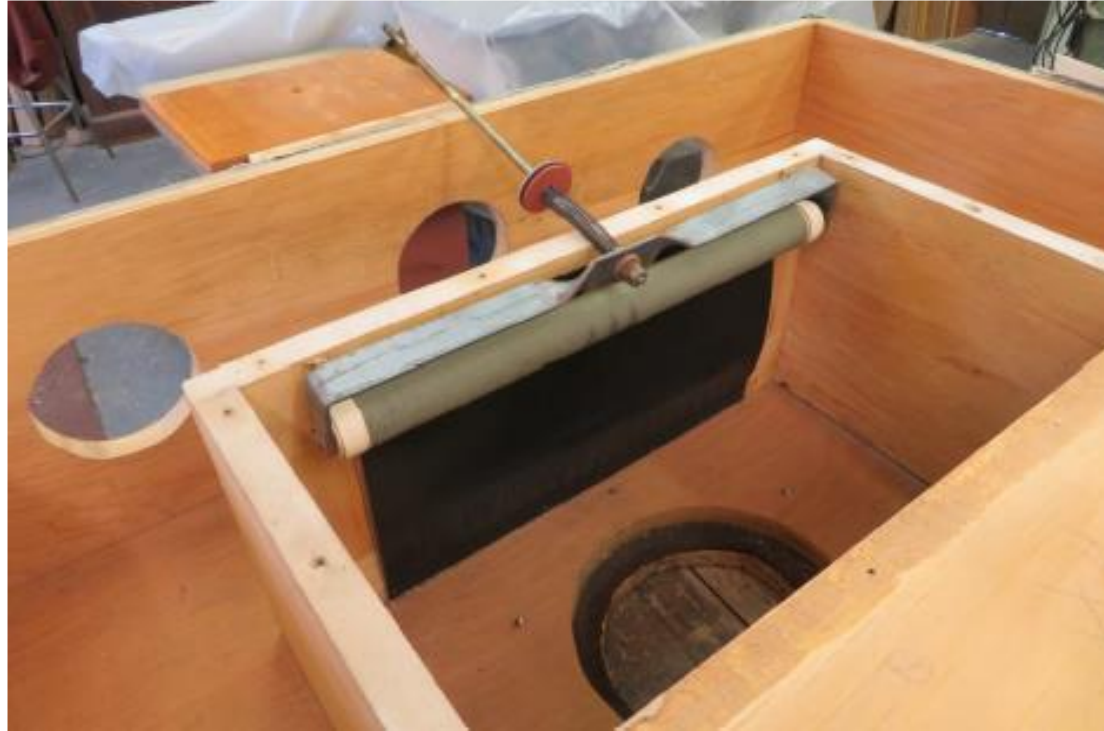
This is the curtain valve inside one of the two Pedal reservoirs. These cut-off devices restrict the in-flow of static wind pressure as the individual reservoir rises, thus maintaining equilibrium in the wind supply and the specific pressure regulations being fed to the Pedal pipework.

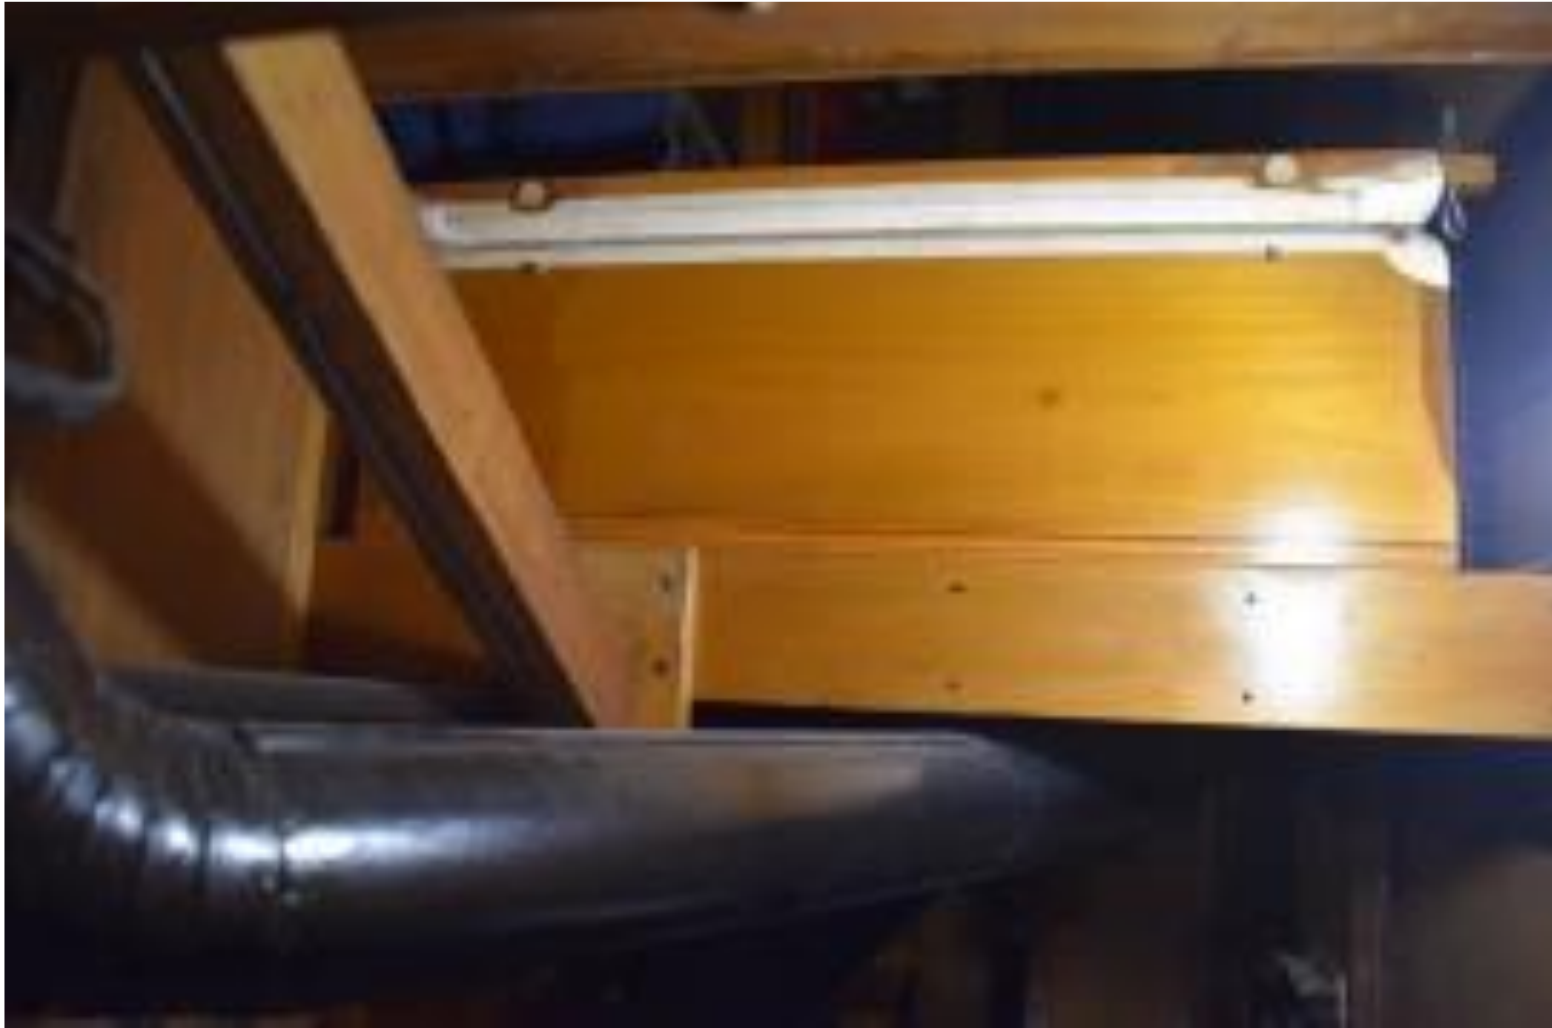
The Choir wind reservoir in place within the organ case.

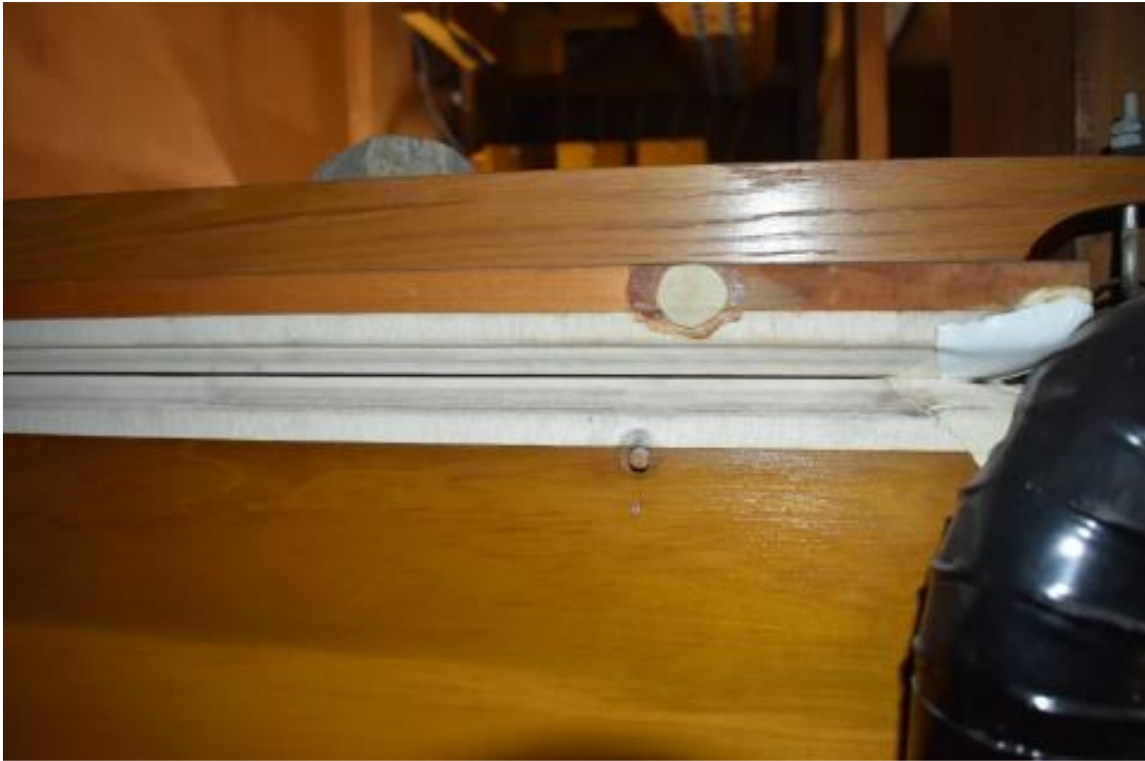
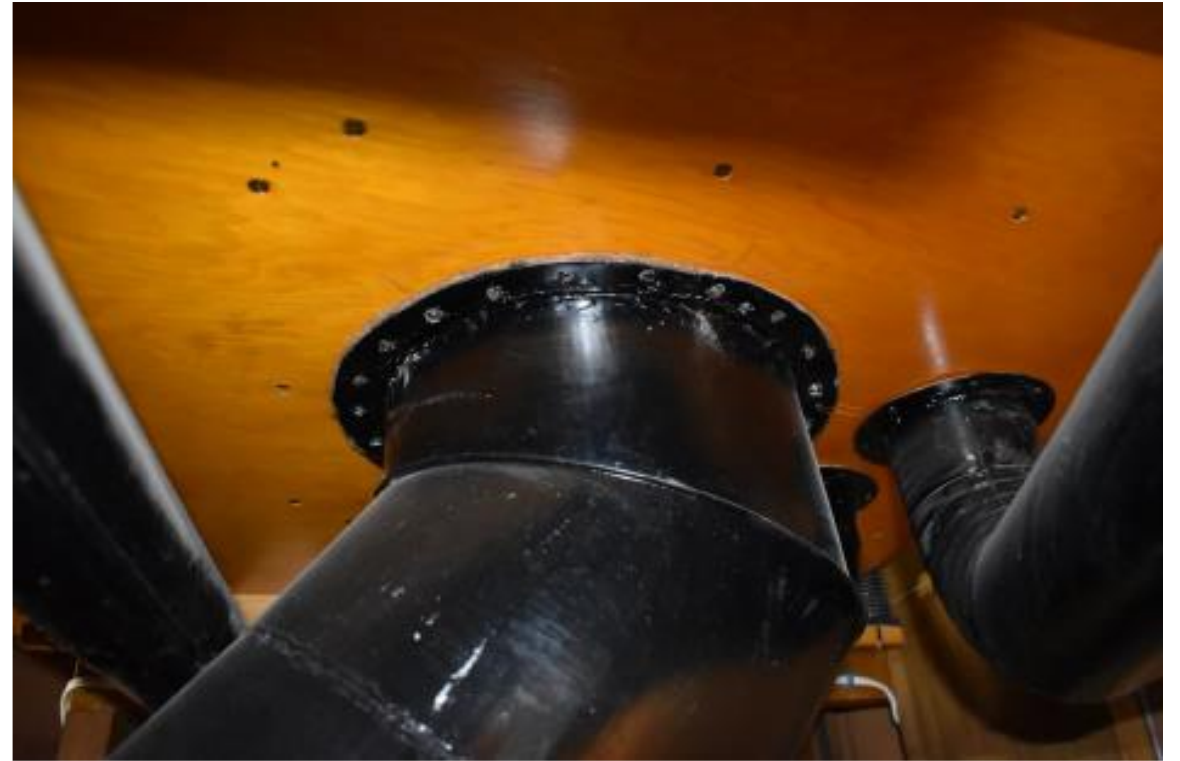
The Choir wind reservoir and its various wind ducts delivering or conveying wind pressure in and out of the regulator box.

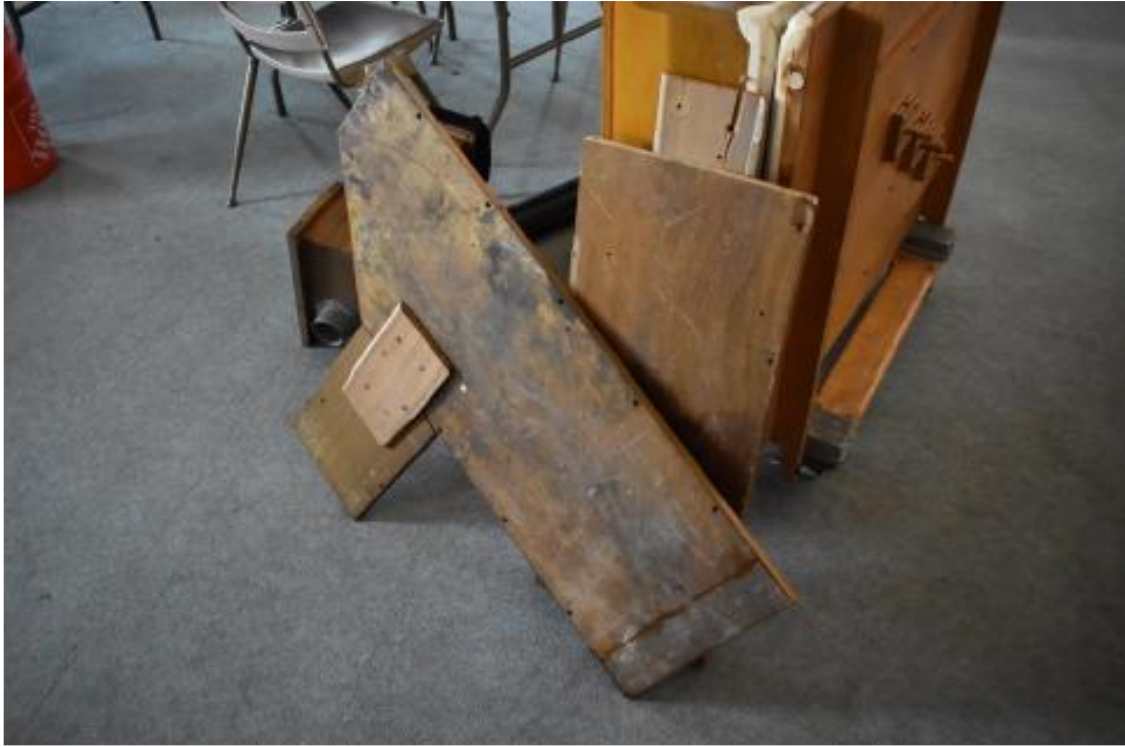
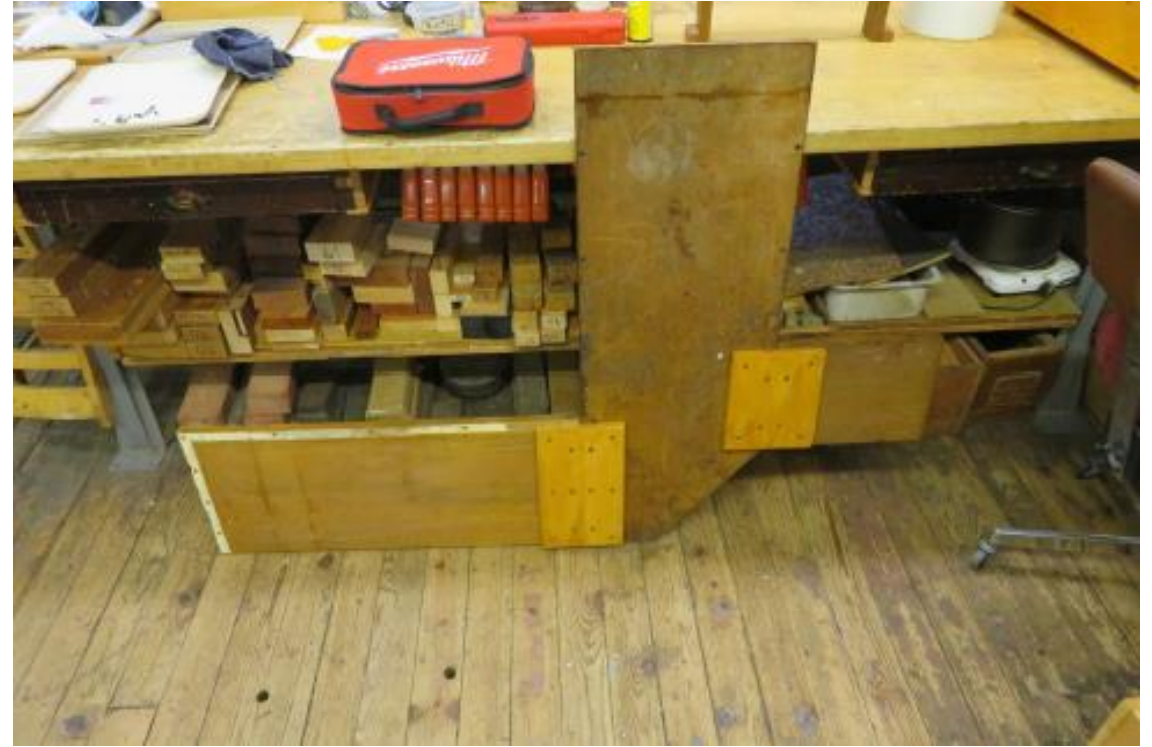
The same parts awaiting loading and, later still, the same parts have been cleaned and rebuilt in the shop with stronger connections before their reinstallation

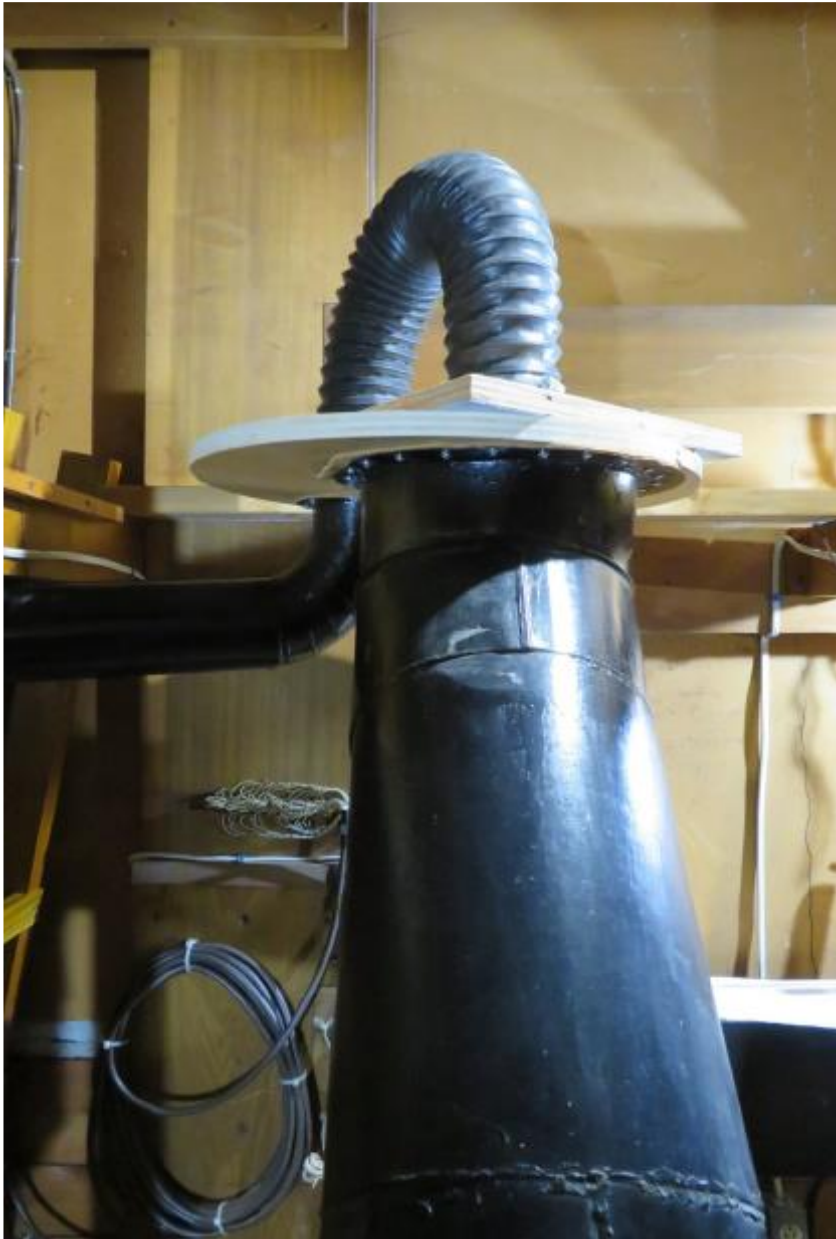
On January 19, 2022, this special adaptor was installed and connected to secure wind-pressure lines so that the Swell stop actions would continue to function.

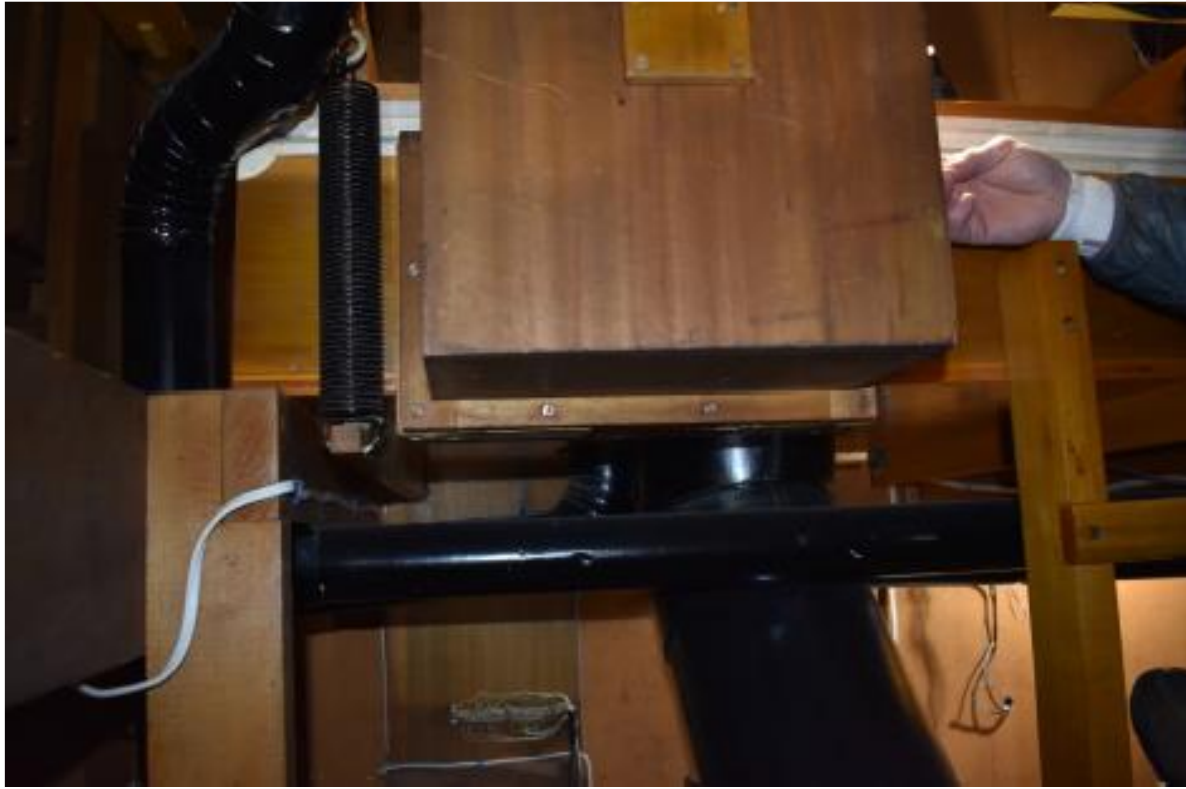
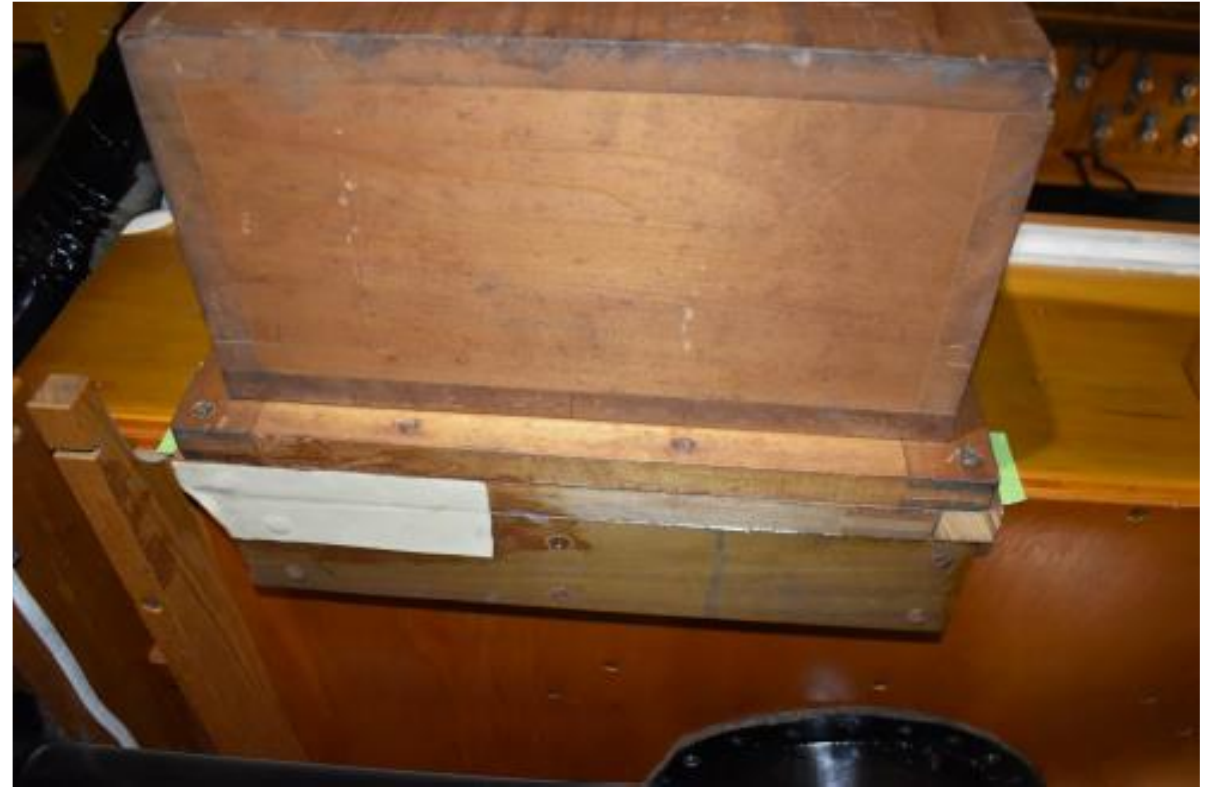
The wooden wind trunk connecting the Choir reservoir to its windchest

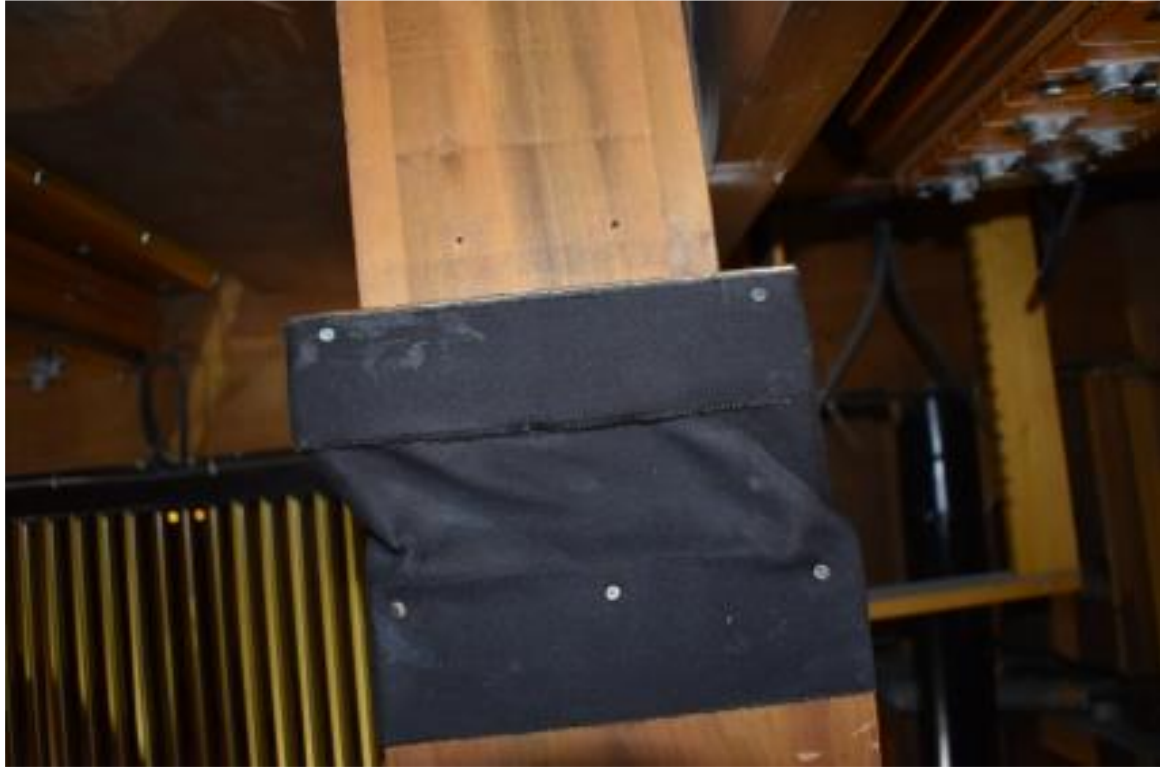
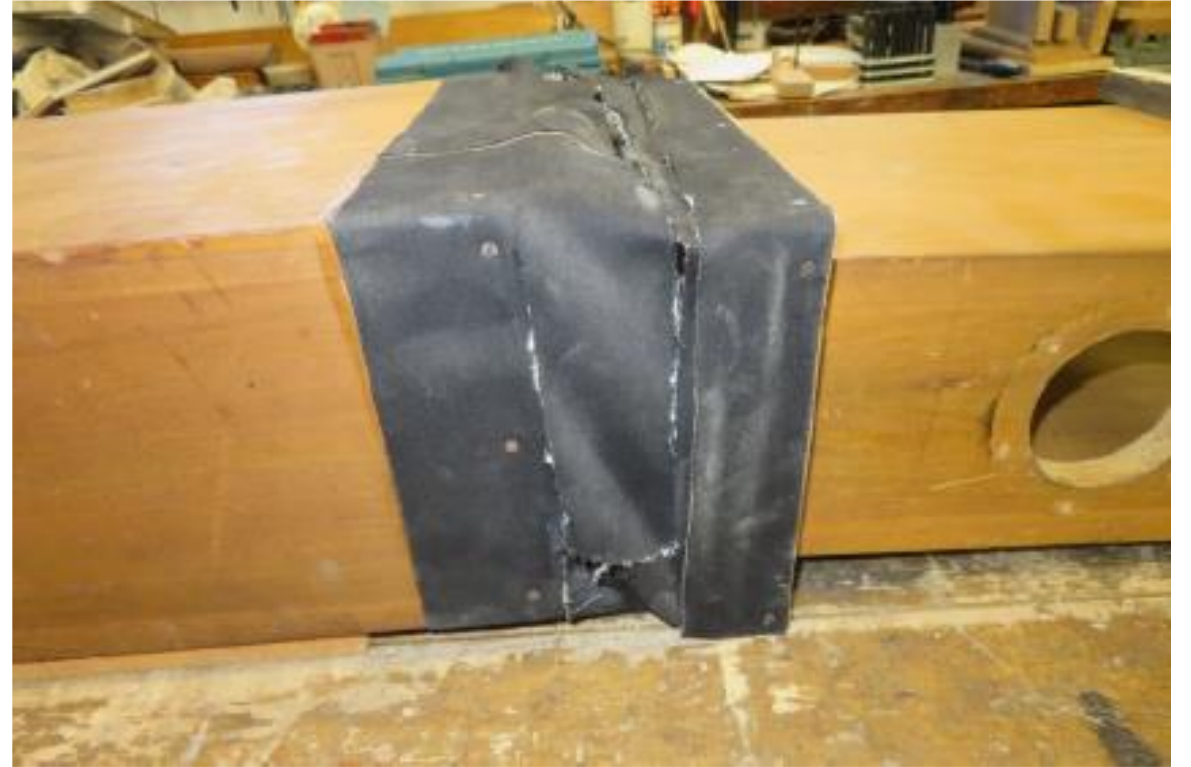
This is the wooden wind trunk. The gold-colored tubes of the Chimes accessory can be seen hanging in the background

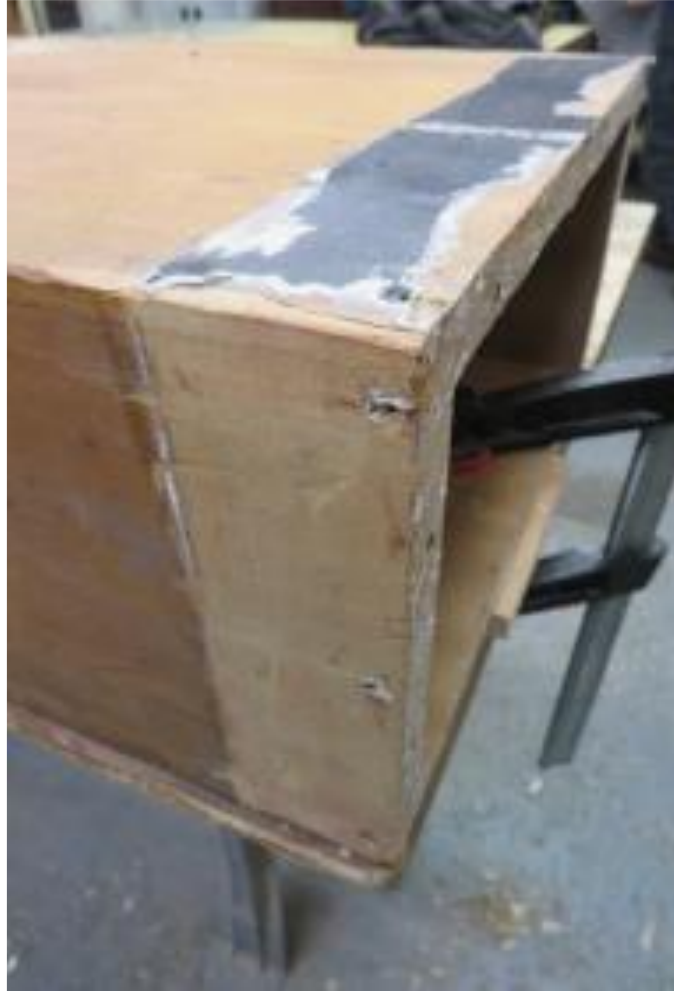
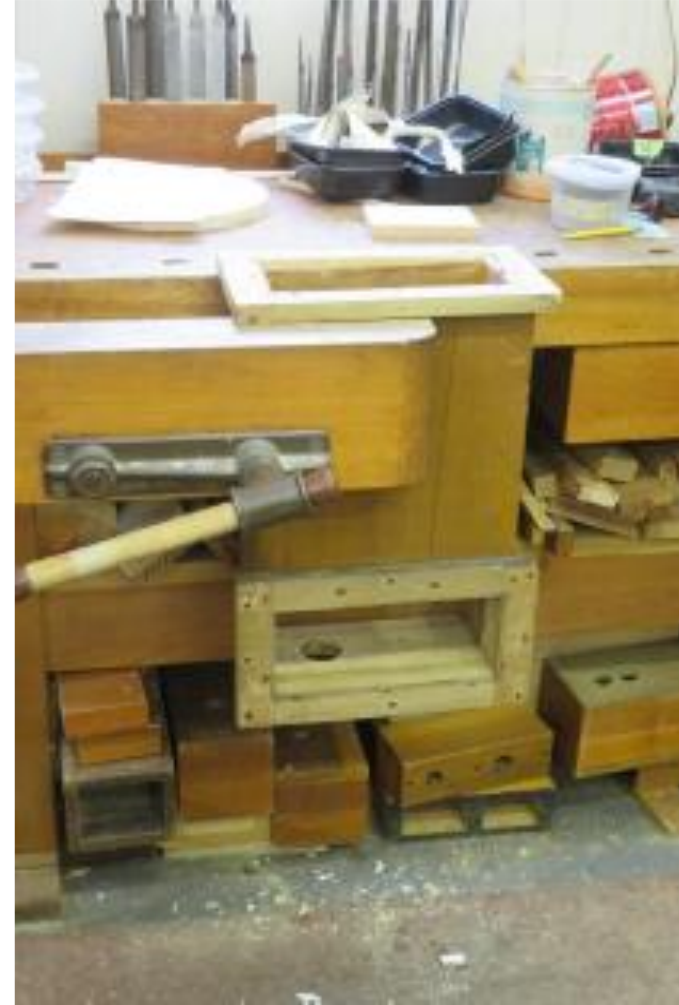
The wooden wind trunks are disassembled for stripping and cleaning in preparation for repairs and releathering

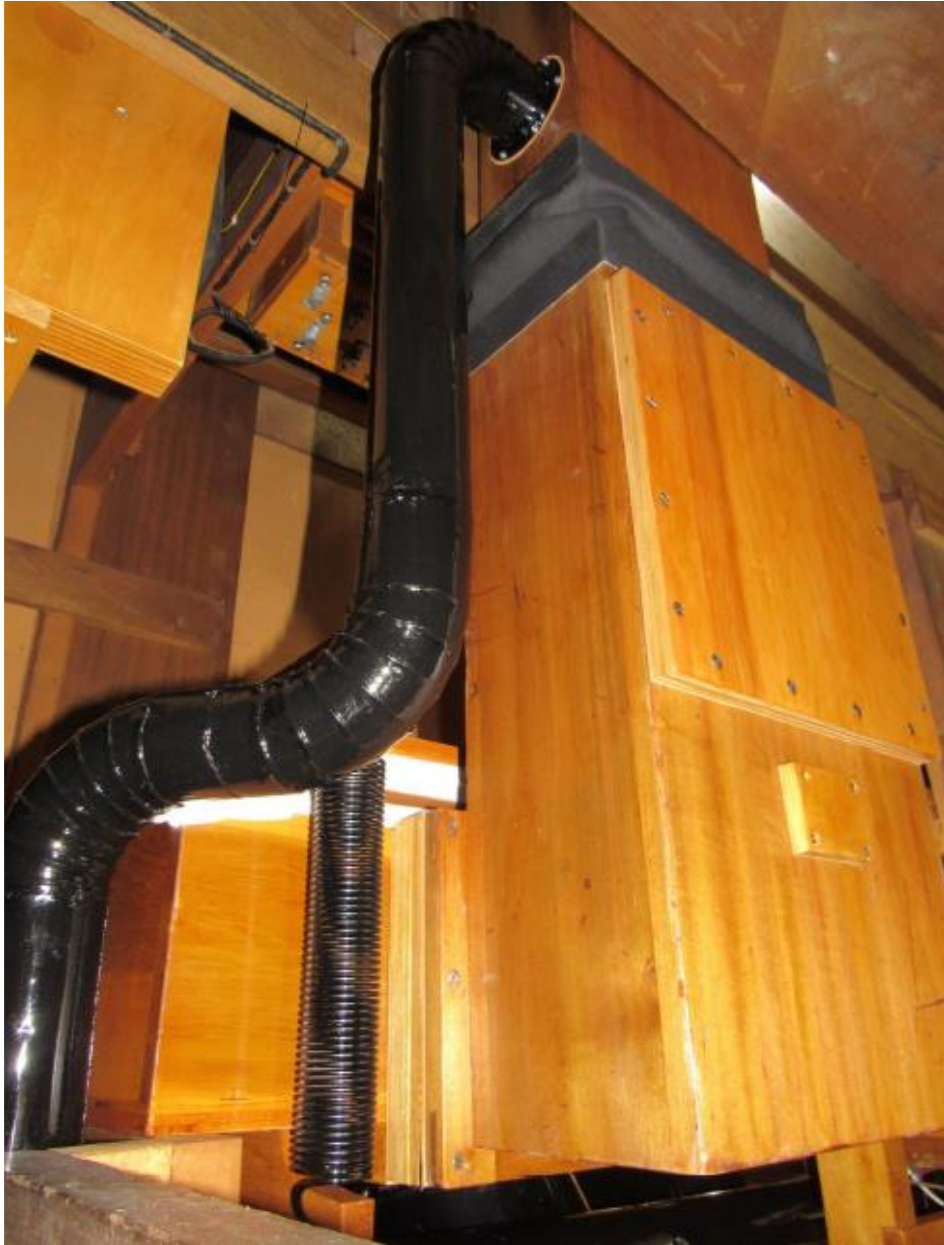
The wind-pressure conveyance reinstalled between the reservoir and windchest inside the organ chamber, with the black pipe connecting the regulated Choir division wind pressure to the accessory Tremolo machine located on the floor of the organ chamber

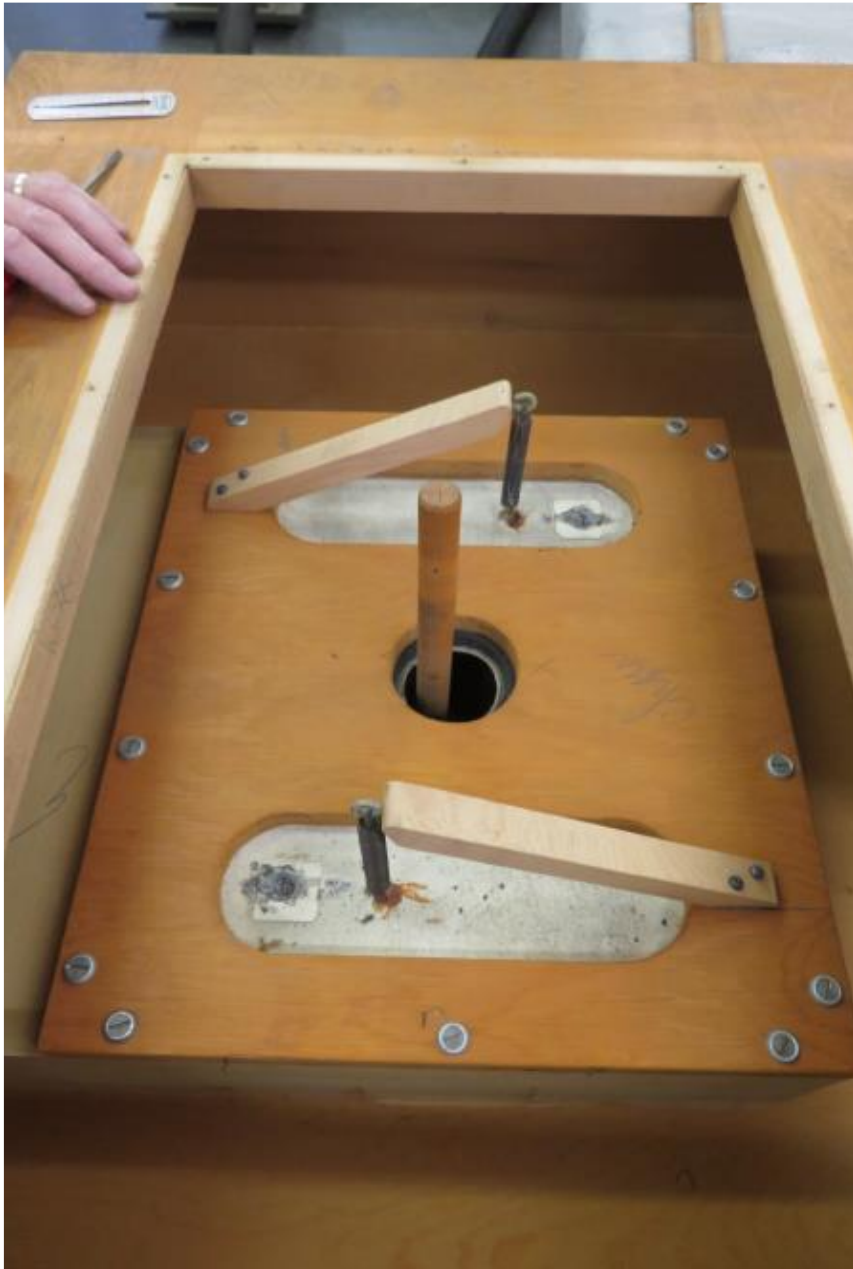
The wind-flow regulator valves were examined, documented, and removed for re-leathering restoration

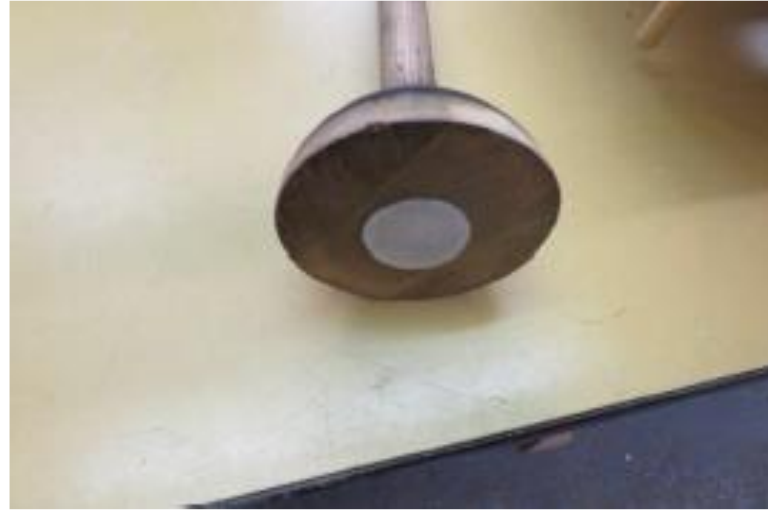
The inside view of the wind-flow regulator valves
and the small cone valve
