Great Division Wind Reservoir – Phase I

On Monday, August 9, 2021, a crew from Messrs. Czelusniak et Dugal, Inc., went to the First Church of Monson to disconnect and remove from the organ and the church the main wind reservoir for the Great division of the pipe organ, the same component then to proceed directly through the thorough shop releathering restoration. The following images document that entire process.

Pedal Division Wind Reservoirs – Phase II

Choir Division Wind Reservoir – Phase III

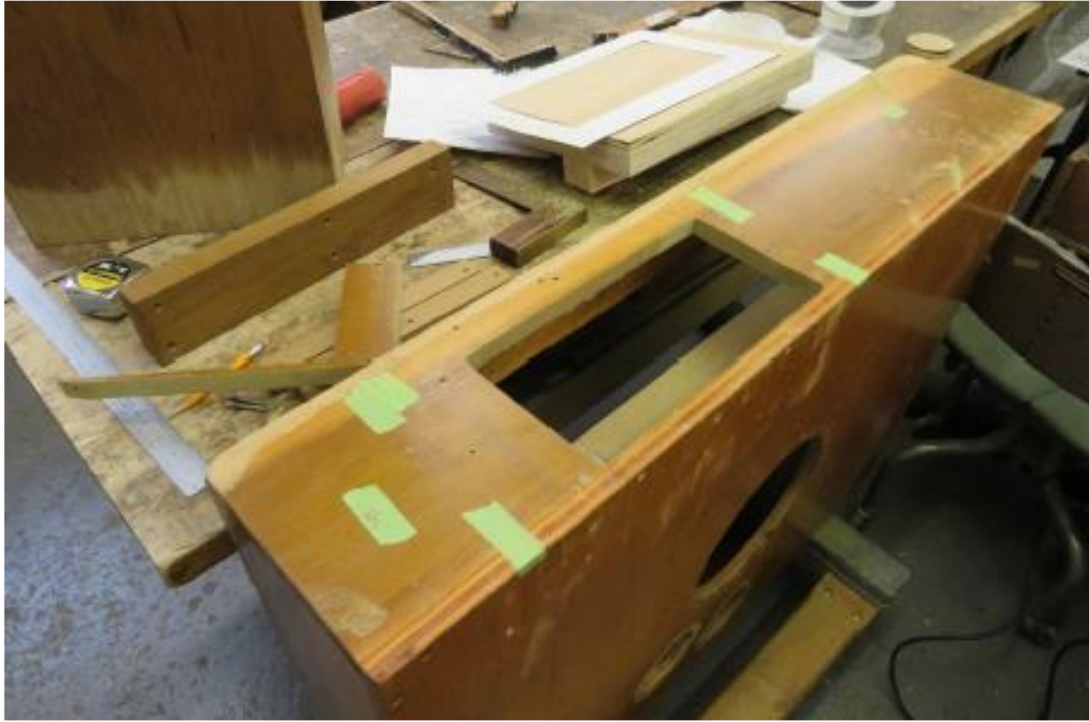
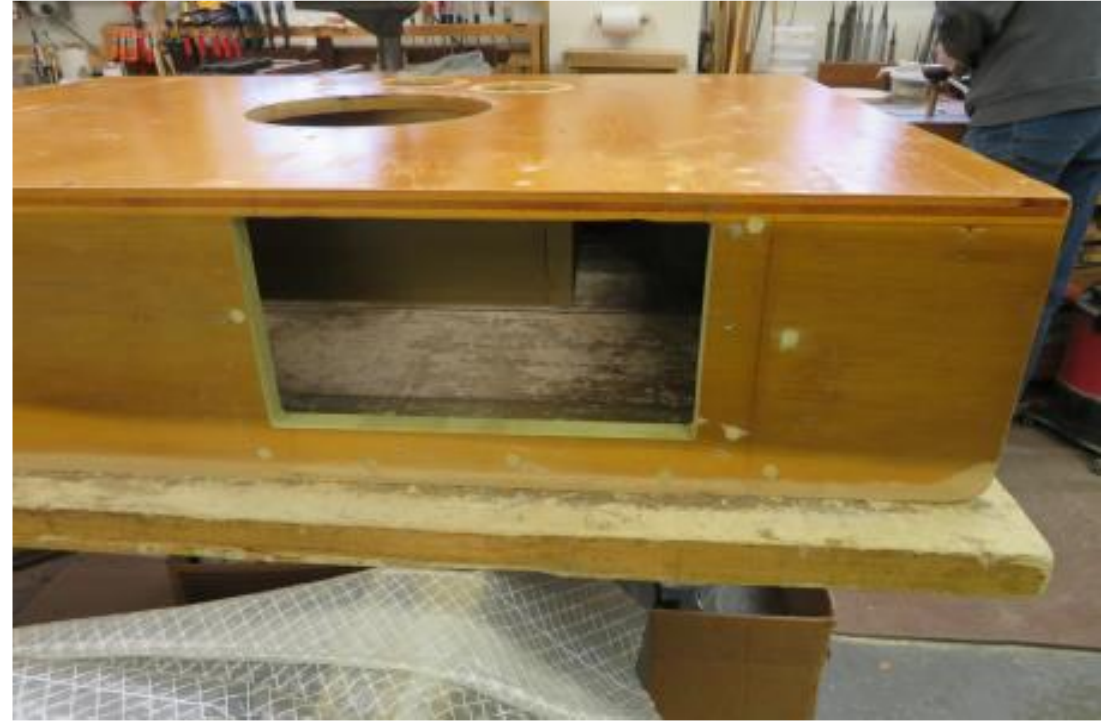
Meanwhile, the main windbox of the Choir division reservoir has been stripped down and was undergoing repairs.

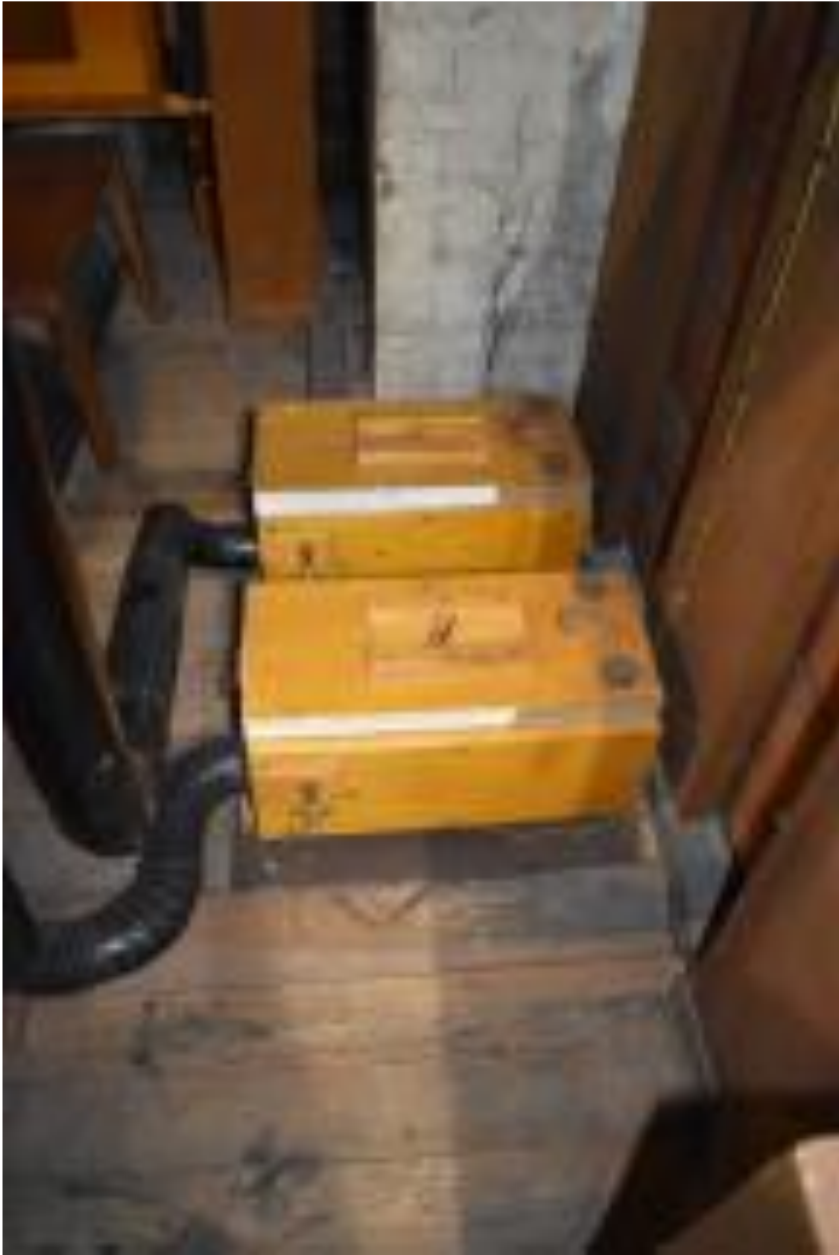
The pair of Tremolos in place on the floor of the organ chamber

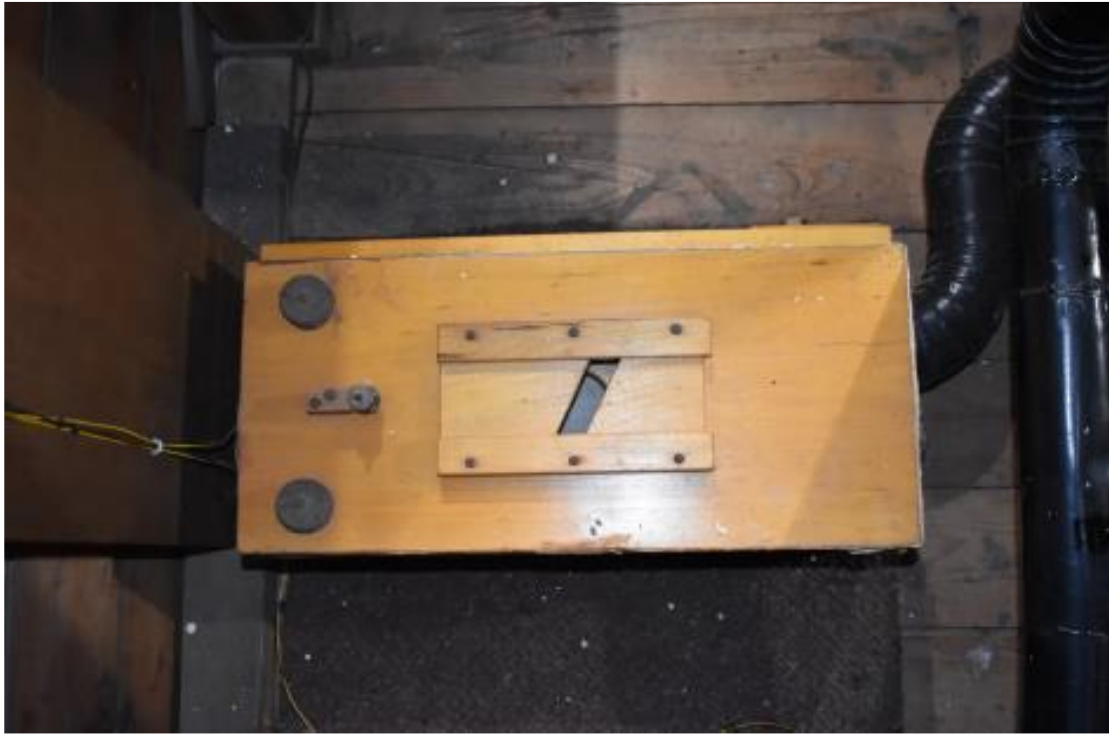
A closer look shows the existing placement, functional settings, wind and wiring connections, operating settings and prevailing conditions of the leather

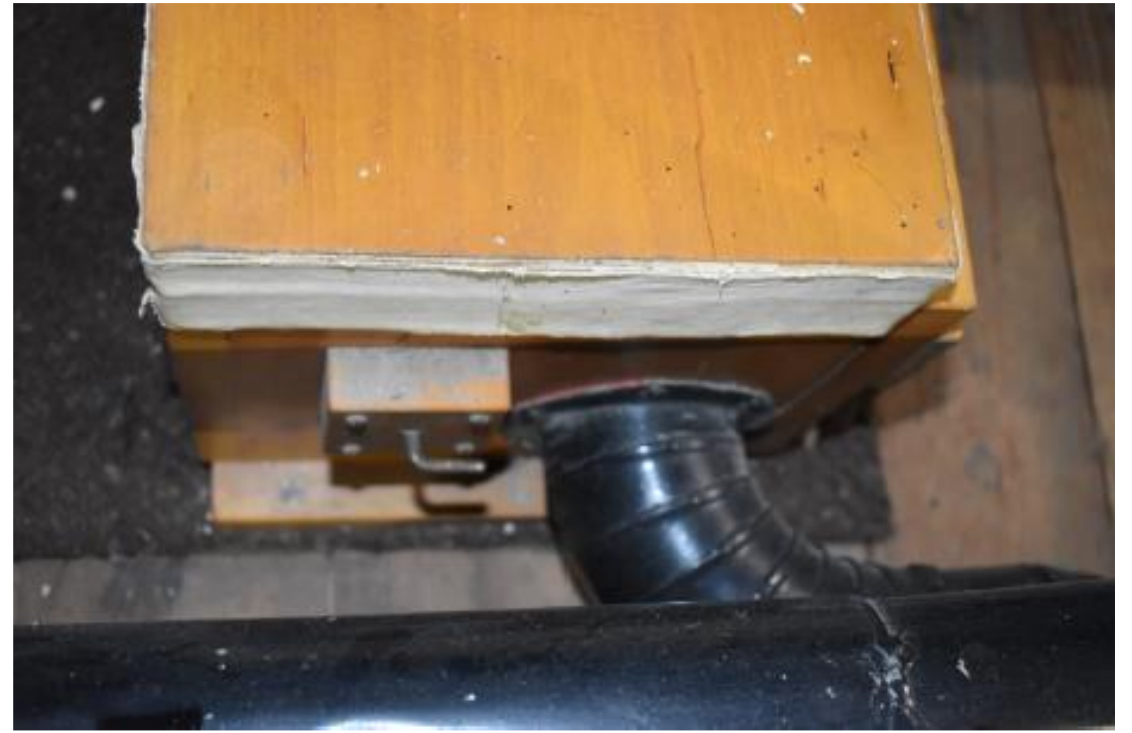
This end-view shows the wind connection from the divisional reservoir and the depth-adjustment screw for the Tremolo effect

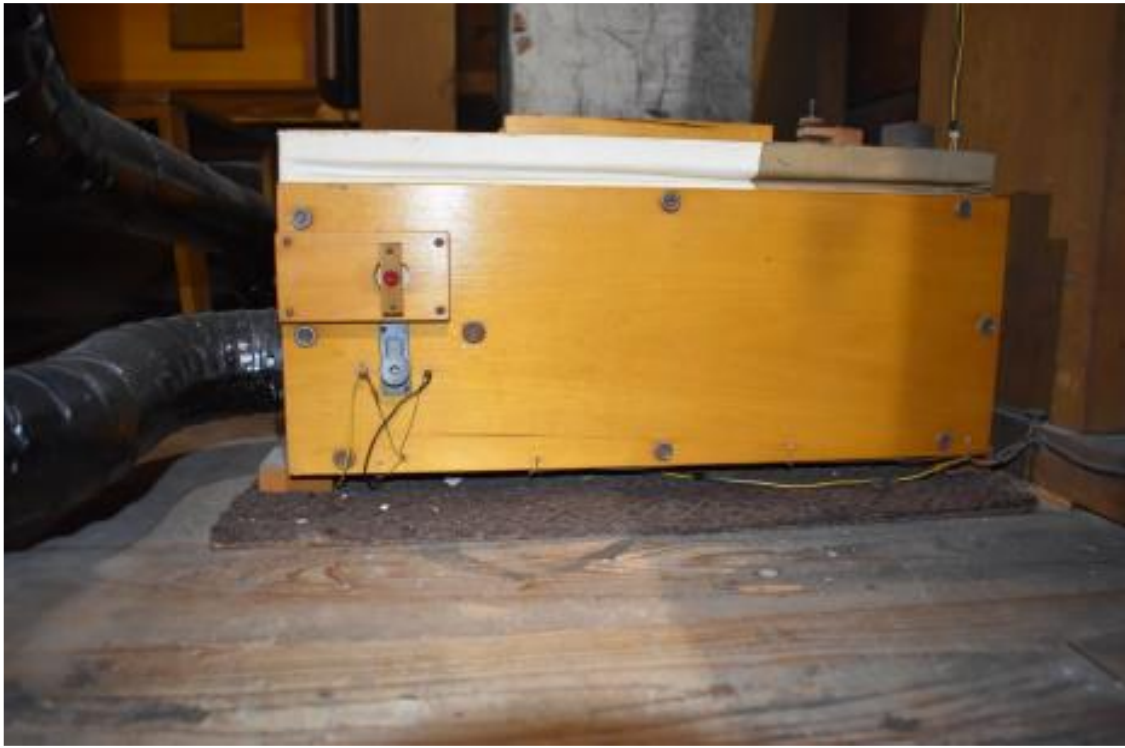
The side-view shows the connection from the console draw knob and the stop-action magnet and primary valve for the Tremolo operation

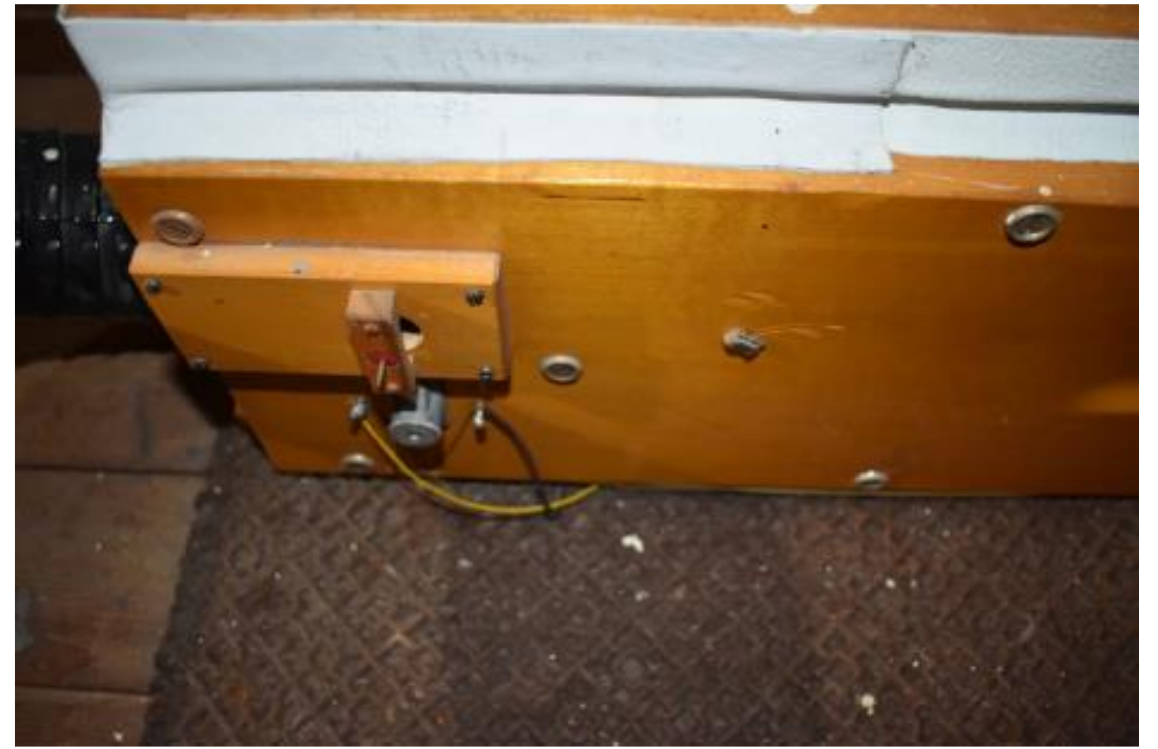
A closer look at the stop-action control for one of the two units

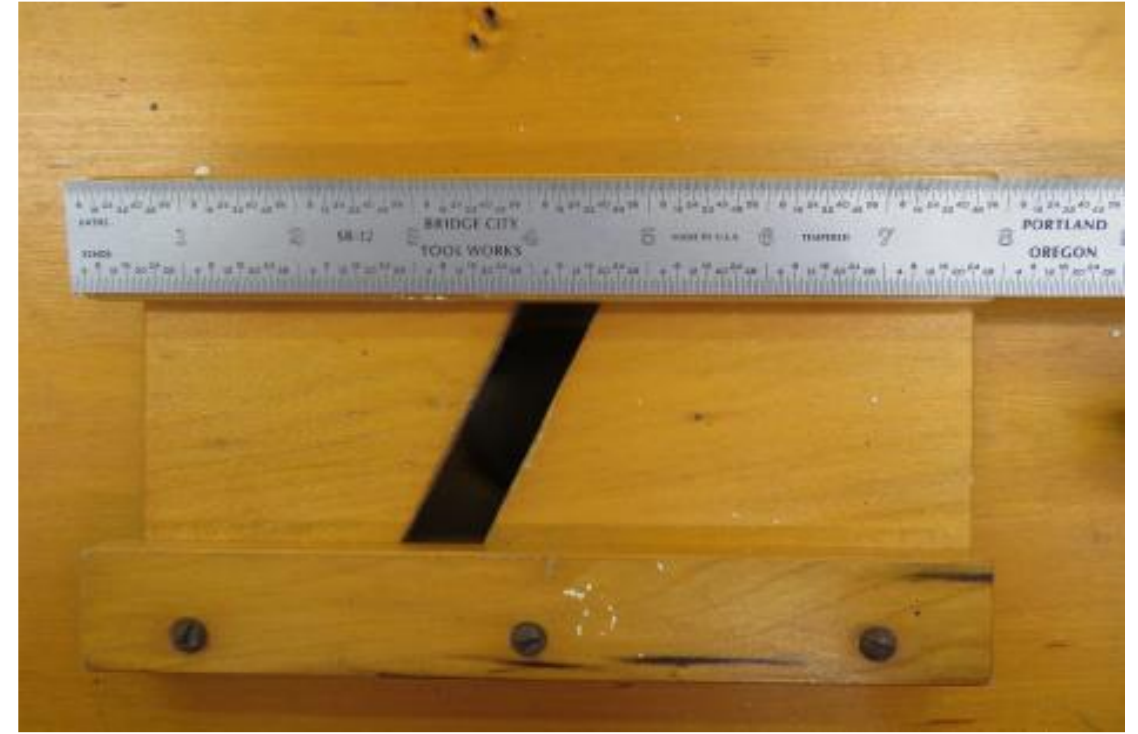
Closer measurements are taken to document the existing settings of the internal exhaust valve and of the opening of the exhaust pipe. These numbers give us a starting point for the operating settings of valves and effects

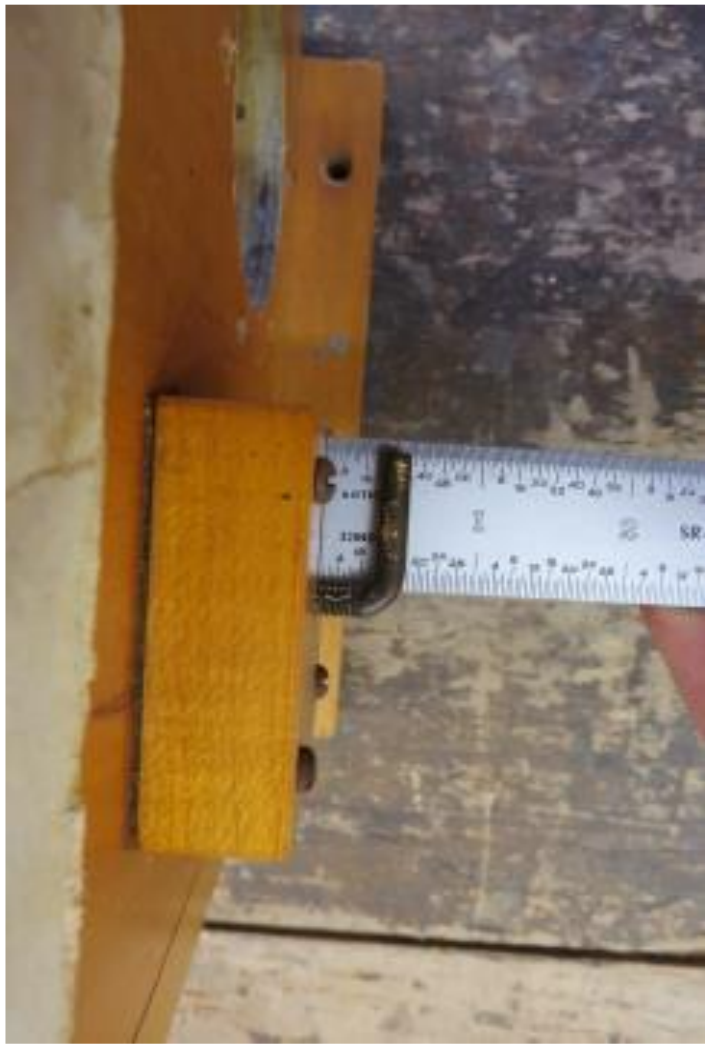
The shop measurement for the depth of the Tremolo effect

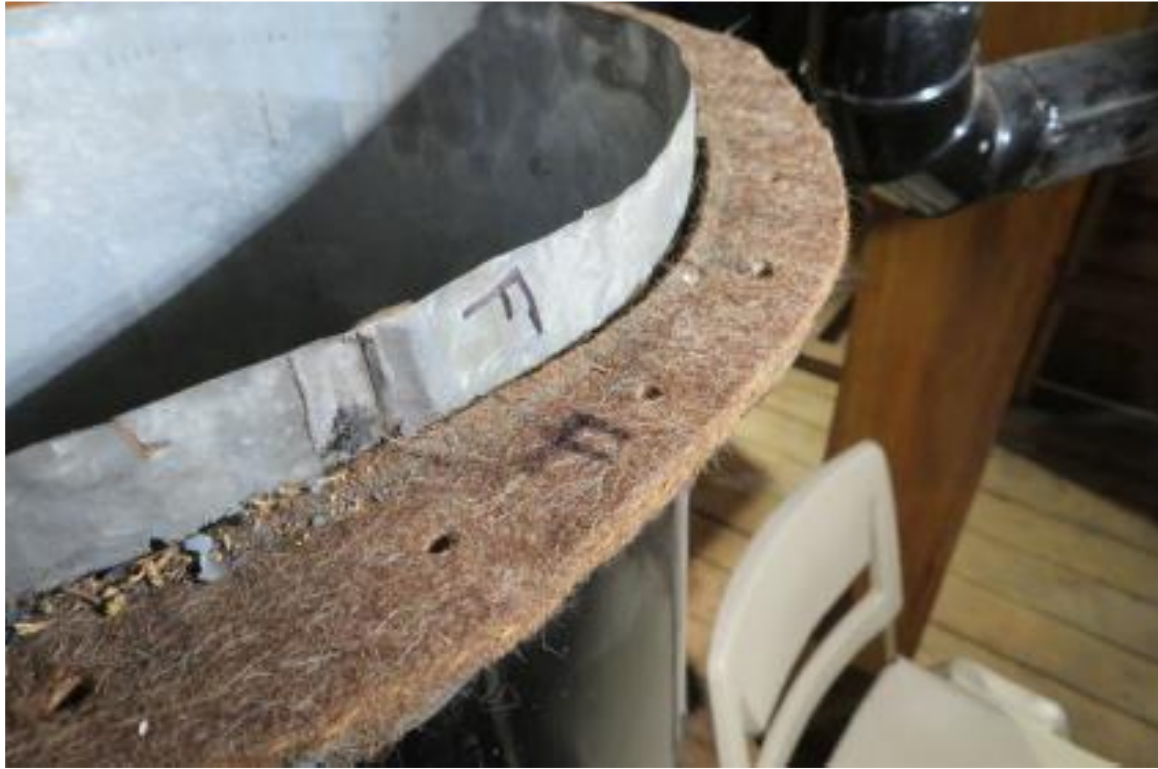
The original gasket between the static-wind delivery line and the bottom of the Swell wind reservoir box

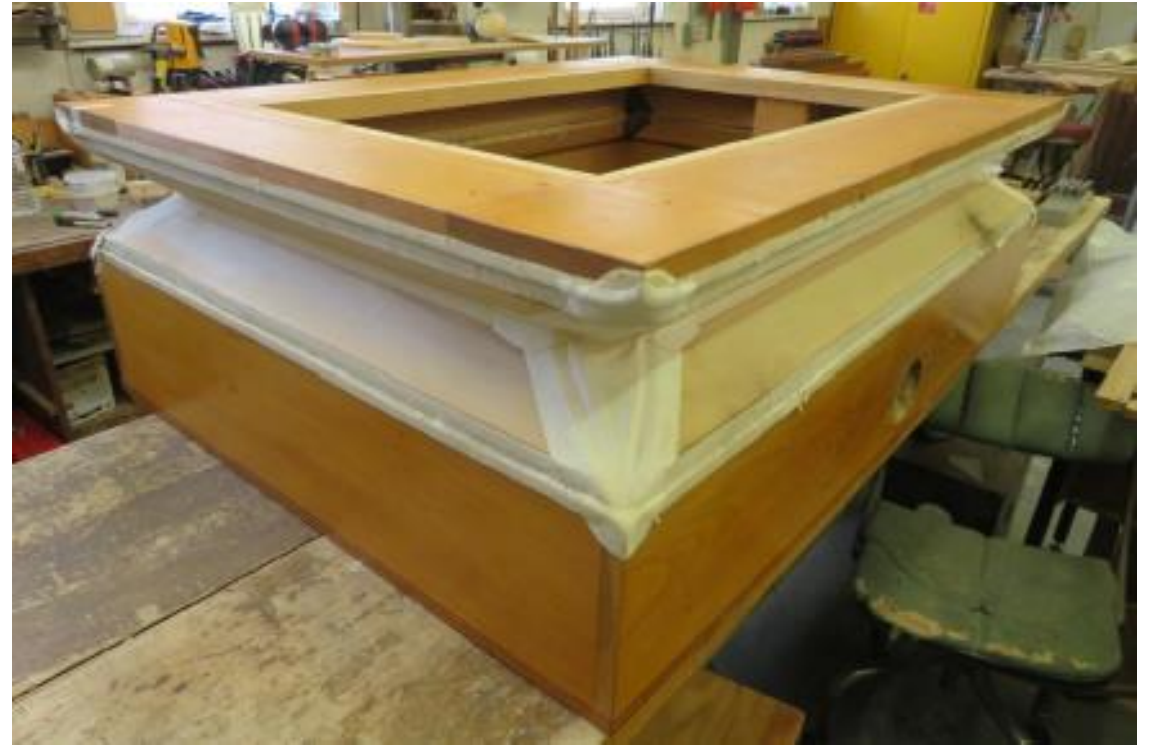
The Swell wind reservoir came apart for inspection, documentation, and disassembly and stripping for restoration

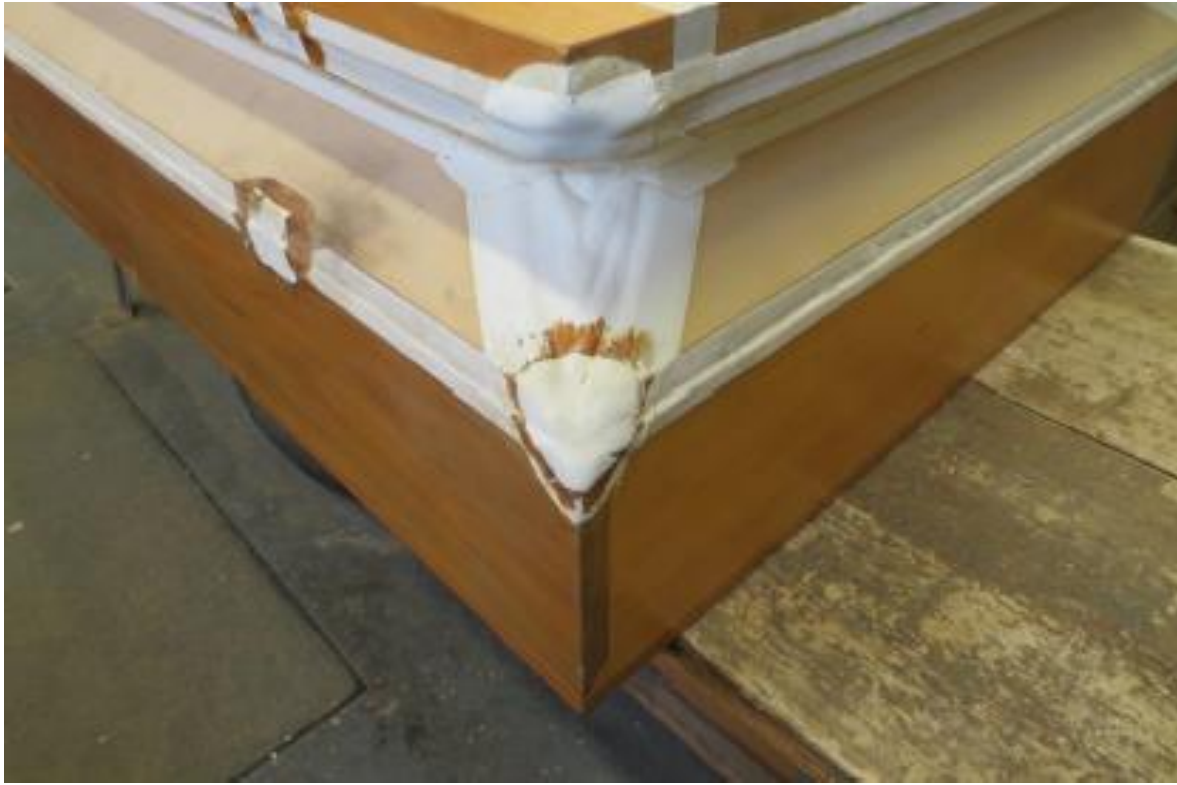
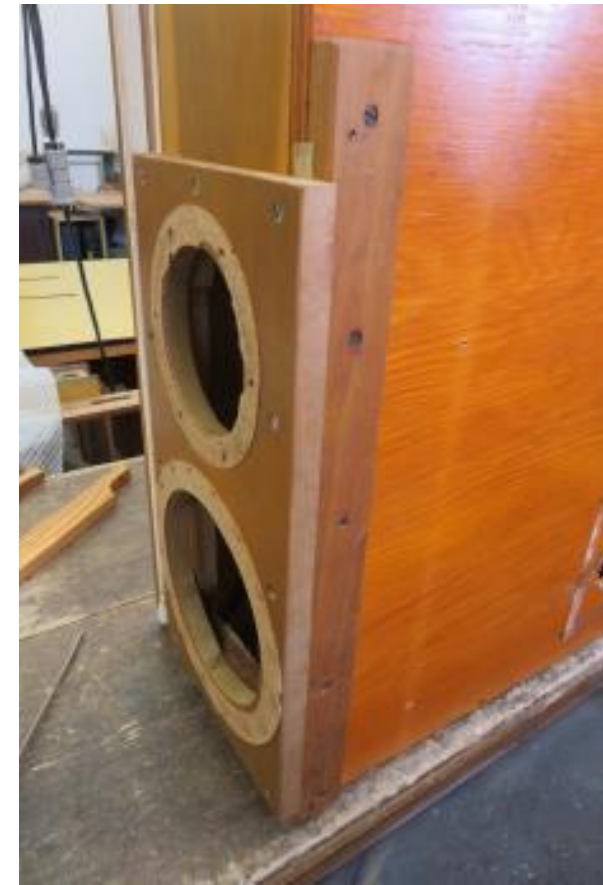
The Swell wind reservoir also required exceptional attention to the condition, repair, and improvement of the flanges, screw joints, and wind conveyances for pressure connections between the reservoir and the windchest
